**Improving Urban Governance and Infrastructure Program
(IUGIP)**

**Environmental Screening
Report for**

LIN Upgradation at Kalkini Pourashava

Sub-Project No: IUGIP/KALK/SI/05-08/2023

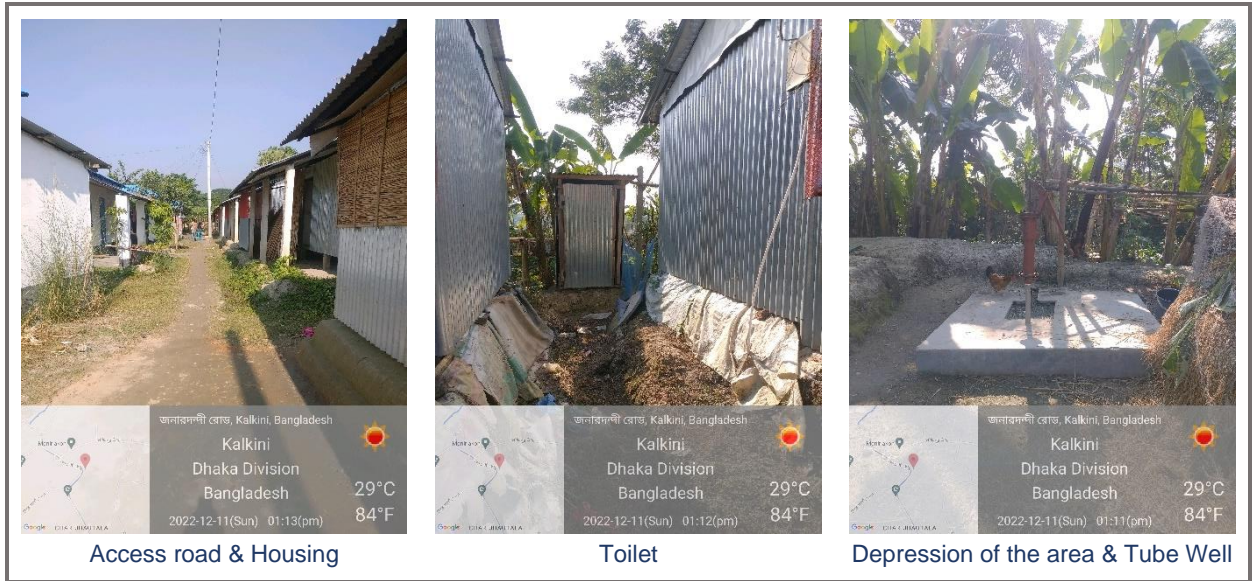
Figure IV.1: Photographs of Existing Conditions of Lamchori LIN

11. Flood does not occur in this LIN. There exist no paved internal drainage systems in the LINS. The existing drains are earthen that are poorly functioning. As the LIN areas are low-lying, heavy rainfall during the rainy season creates waterlogging. Hence, the construction of drains is necessary to remove water logging conditions in these LINS.

13. There is no existing sufficient sanitary toilet facility in the LIN area. LIN dwellers are facing a scarcity of hygienic sanitation; refer to **Figure II.1** for the existing condition of toilet facilities. Hence, they have demanded the construction of 12 nos. of sanitary toilets to improve the sanitation condition of their area. Refer to **Appendix 1** for the typical design of the proposed improved toilet.

14. There is no existing paved road/walkway in the LIN area. Refer to **Figure II.1** for the existing condition of access roads. LIN dwellers want 220m of footpaths for their improved communication system within the LIN area. The proposed footpaths have been designed with cement concrete (CC) pavement over a prepared sub-base with crushed stone chips and/or Single Layer Brick Flat Soling (BFS). The LIN area is connected to Pourashava roads. A typical design of the footpath is given in **Appendix 1**.

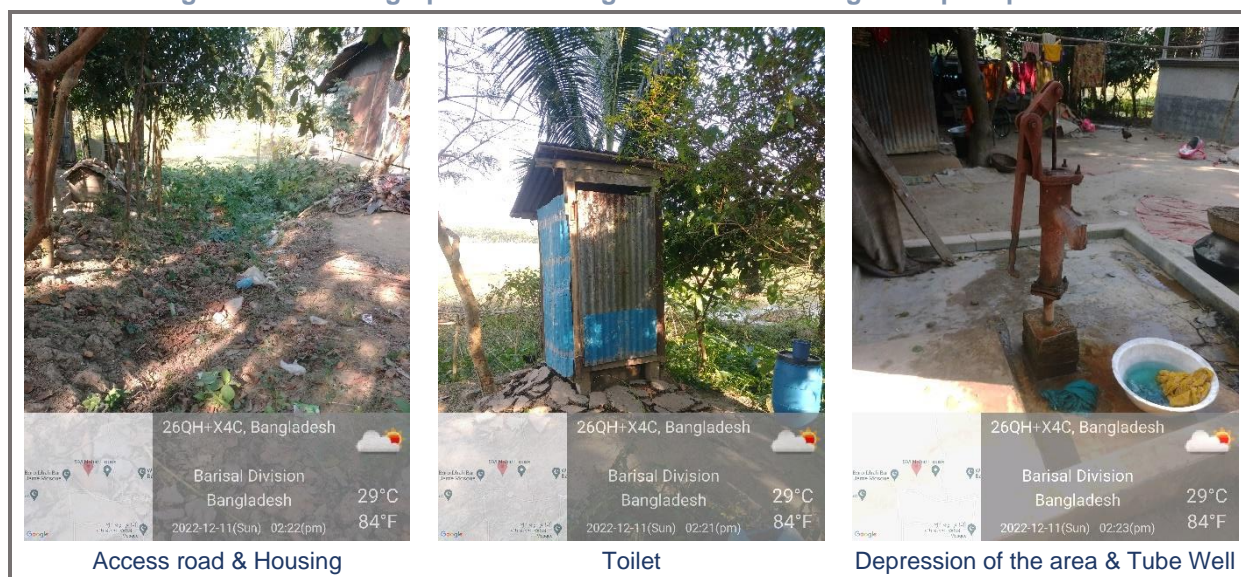
Figure IV.5: Photographs of Existing Conditions of Jurgao Wapder par LIN

61. There is no existing sufficient sanitary toilet facility in the LIN area. LIN dwellers are facing a scarcity of hygienic sanitation; refer to **Figure II.5** for the existing condition of toilet facilities. Hence, they have demanded the construction of 13 nos. of sanitary toilets to improve the sanitation condition of their area. Refer to **Appendix 1** for the typical design of the proposed improved toilet.

64. The existing drains are earthen and inactive; refer to **Figure II.5** for the existing condition of drains. So, LIN dwellers experience water logging, especially during the rainy season. Hence, they have demanded construction of 50m of drains in their area. The proposed drains in the LINs have been considered tertiary drains, and their outfalls are all Paura secondary drains that discharge into primary drains. All drains have been designed to be built by RCC/brick. But well-defined slopes and outfalls have been ensured. The U-type drains have been designed considering the constraint in land availability. The design life has been considered as 20 years. Integration/connection of roadside drains with the town drainage system has been considered, and considering the possibilities of increased precipitation owing to probable climate change, the sections have been designed keeping allowance to accommodate 10% additional flow. A typical design of the drain is given in **Appendix 1**.
