**Improving Urban Governance and Infrastructure Program (IUGIP)**

**Environmental Screening Report for  
LIN Upgradation at FARIDGANJ Pourashava**

**Sub-Project No: IUGIP/FARI/SI/01-04/2023**

*January 2025*

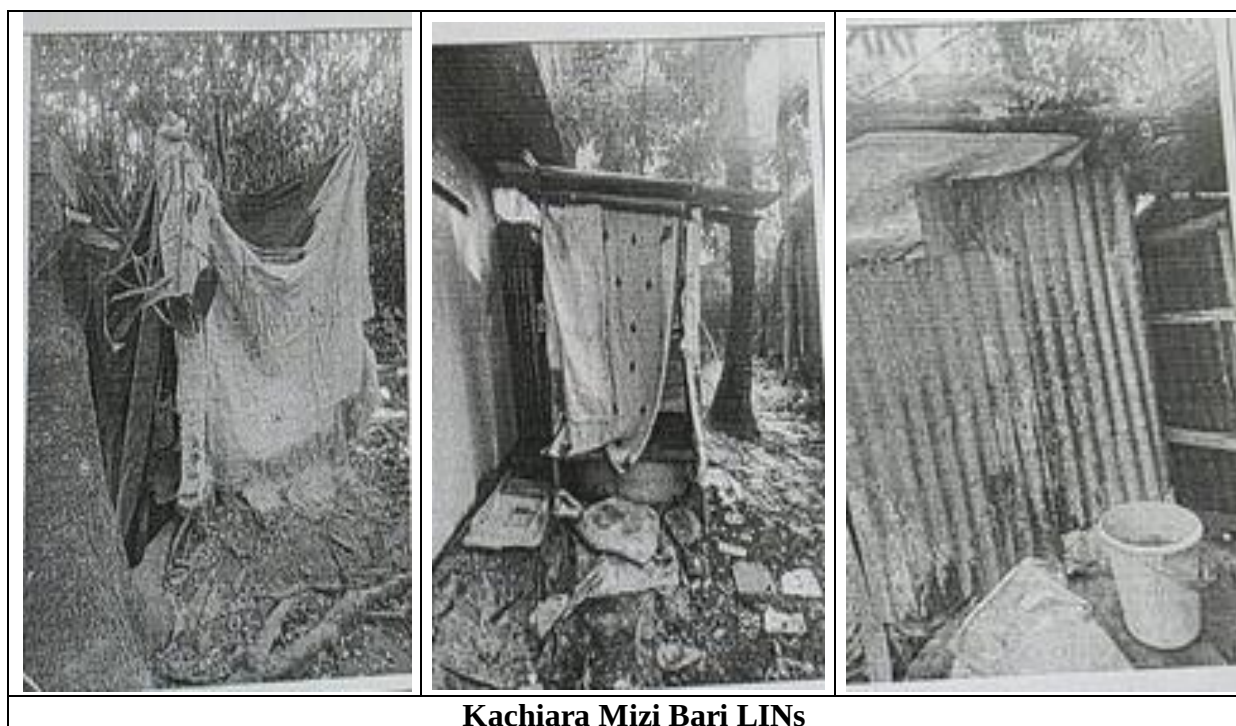
**Figure IV.2: Existing Situation at Kachiara Mizi Bari LIN**

35. Flood does not occur in this LIN. The existing drains are earthen and are not functioning. Water logging condition occurs due to heavy rainfall during rainy season. Rain water in the monsoon and the water coming out from bathing and washing round the year are stagnant there. As such water logging becomes a common feature there. Construction of drain is necessary in this LIN.

38. There exists earthen access road in the LIN area and no pacca walkway also in the LIN area. LIN dwellers wanted footpath for their communication within the LIN area. 994 m are being proposed in this summary. LIN area is connected by Pourashava roads. The proposed Footpaths have been designed with cement concrete (CC) crushed stone chips and over Single Layer Brick Flat Soling (BFS). LIN area is connected by Pourashava roads. Images of existing access roads of the LIN are shown in Figure II.3. Typical design of footpath is given in Appendix-1.

40. The existing drains are earthen and are inactive. So, the LIN dwellers experience water logging especially during rainy season. The out fall of proposed drain is Pourashava existing drain (Section-3 site map) and the coming water to the proposed drain 140m is only from rainfall run-off or household waste water. All drains have been designed to be built by RCC. But well-defined slopes and outfalls have been ensured. The U-type drains have been designed considering the constraint in land availability. The design life has been considered as 20 years. Integration/connection of Road side drains with the town drainage system has been considered and considering the possibilities of increased precipitation owing to probable climate change, the sections have been designed keeping allowance to accommodate 10% additional flow. Typical Design of drains is given in Appendix-1;
