Improving Urban Governance and Infrastructure Program (IUGIP)

**Environmental Screening Report for
LIN Upgradation at Santhia Pourashava**

Sub-Project No: IUGIP/SANT/SI/01-06/2023

JULY 2025

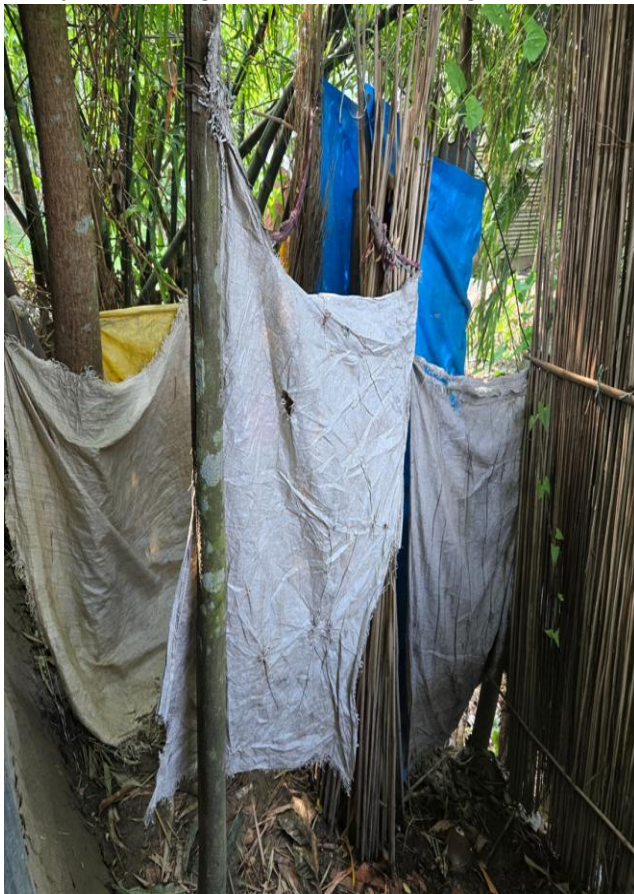
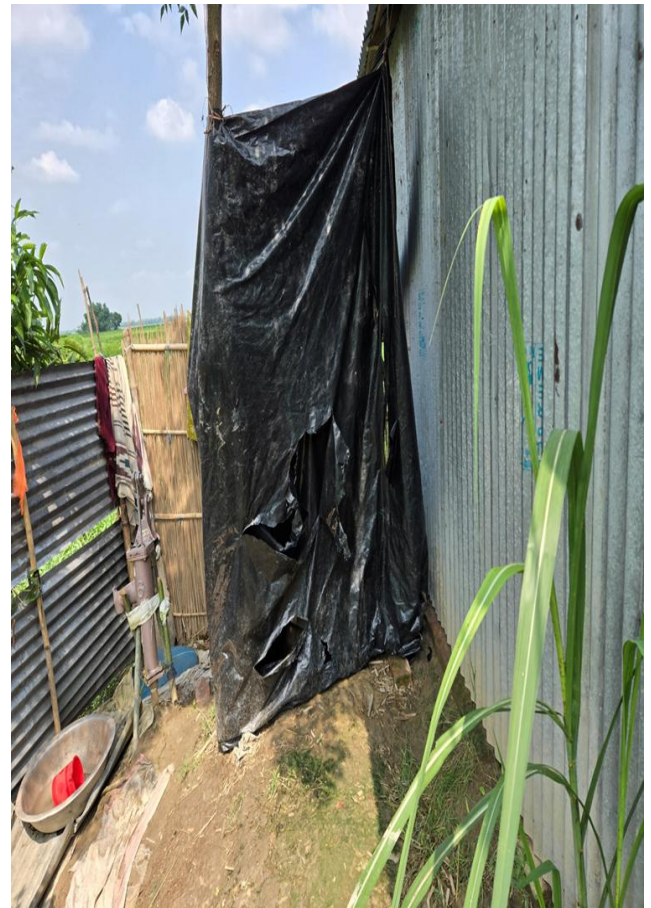
Figure IV.1: Existing Situation at PURBO PARA -LIN

11. Flood does not occur in this slum. There exist no paved internal drainage systems in the slums. The existing drains are earthen that are poorly functioning. As the LIN areas are low-lying, heavy rainfall during the rainy season creates water logging. Hence, the construction of drains is necessary to remove water logging conditions in these LINs.

13. There is no existing sufficient sanitary toilet facility in the LIN area. LIN dwellers are facing a scarcity of hygienic sanitation; refer to **Figure II.1** for the existing condition of toilet facilities. Hence, they have demanded the construction of 19 nos. of sanitary toilets to improve the sanitation condition of their area. Refer to **Appendix 1** for the typical design of the proposed improved toilet.

14. There is no existing paved road/walkway in the LIN area. Refer to **Figure II.1** for the existing condition of access roads. LIN dwellers want 275m of footpaths for their improved communication system within the LIN area. The proposed footpaths have been designed with cement concrete (CC) pavement over a prepared sub-base with crushed stone chips and/or Single Layer Brick Flat Soling (BFS). The LIN area is connected to Pourashava roads. A typical design of the footpath is given in **Appendix 1**.

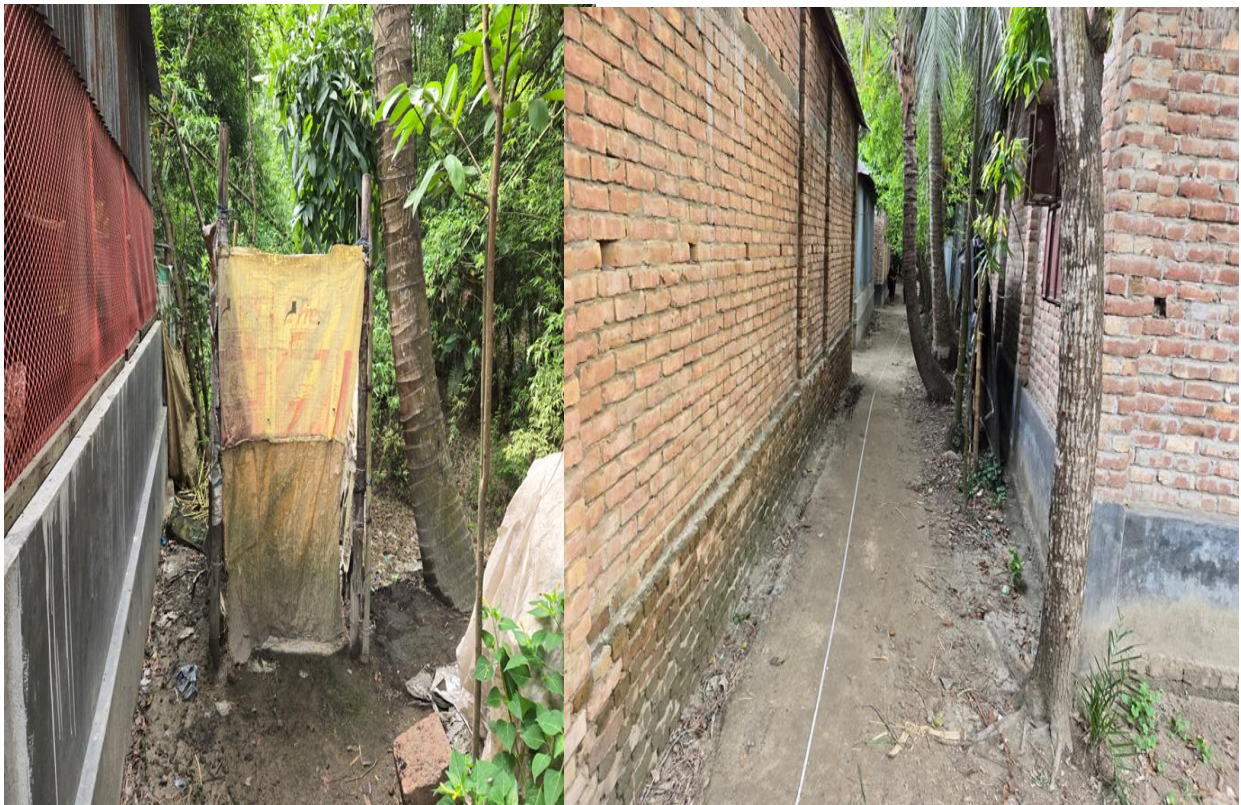
Figure IV.2: Existing Situation at Laxmipur LIN

Flood does not occur in this LIN. The existing drains are earthen and are not functioning. Water logging condition occurs due to heavy rainfall during rainy season. Rain water in the monsoon and the water coming out from bathing and washing round the year are stagnant there. As such water logging becomes a common feature there. Construction of drain is necessary in this LIN.

There exists earthen access road in the LIN area and no pacca walkway also in the LIN area. LIN dwellers wanted footpath for their communication within the LIN area. 260 m are being proposed in this summary. LIN area is connected by Pourashava roads. The proposed Footpaths have been designed with cement concrete (CC) crushed stone chips and over Single Layer Brick Flat Soling (BFS). LIN area is connected by Pourashava roads. Images of existing access roads of the LIN are shown in Figure II.3. Typical design of footpath is given in Appendix-1.

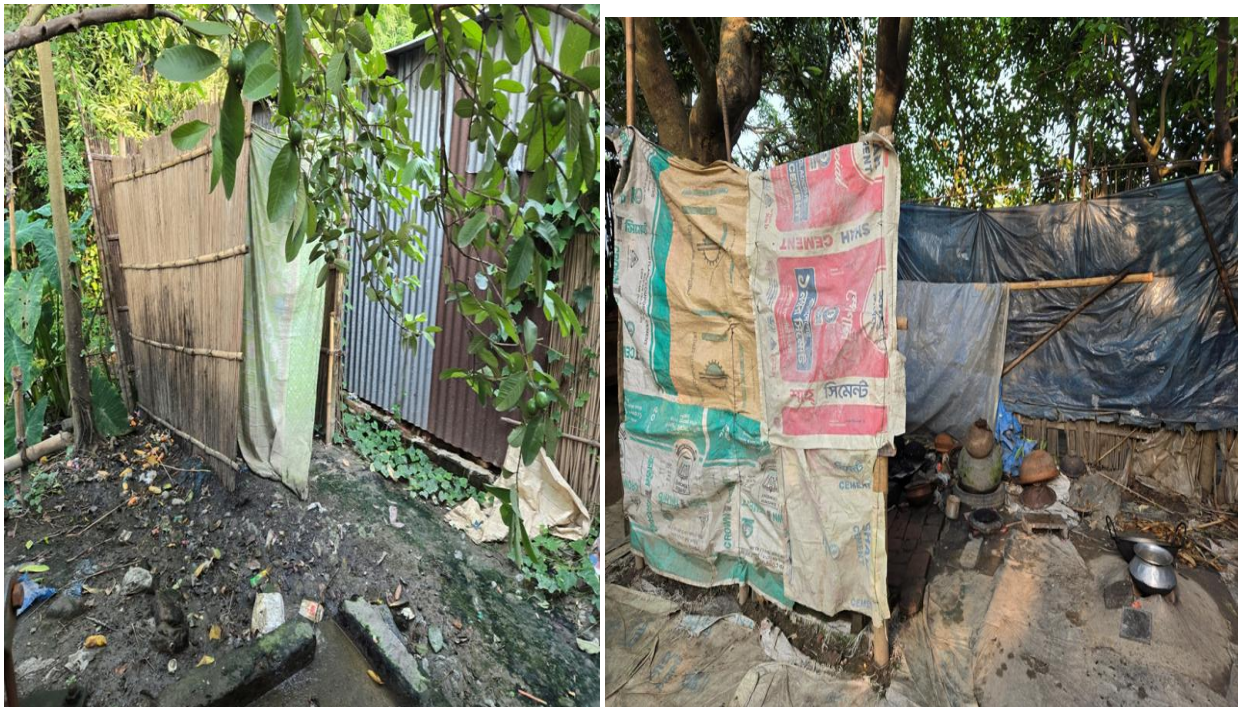
Figure IV.3: Existing Situation at Puthi LIN

64. The existing drains are earthen and are inactive. So, the LIN dwellers experience water logging especially during rainy season. The out fall of proposed drain is Poura secondary drain to primary drain (Section-3 site map) and because as the coming water to the proposed drain is only from rainfall run-off or household waste water. All 20m drains have been designed to be built by RCC/brick. But well-defined slopes and outfalls have been ensured. The U-type drains have been designed considering the constraint in land availability. The design life has been considered as 20 years. Integration/connection of Road side drains with the town drainage system has been considered and considering the possibilities of increased precipitation owing to probable climate change, the sections have been designed keeping allowance to accommodate 10% additional flow.

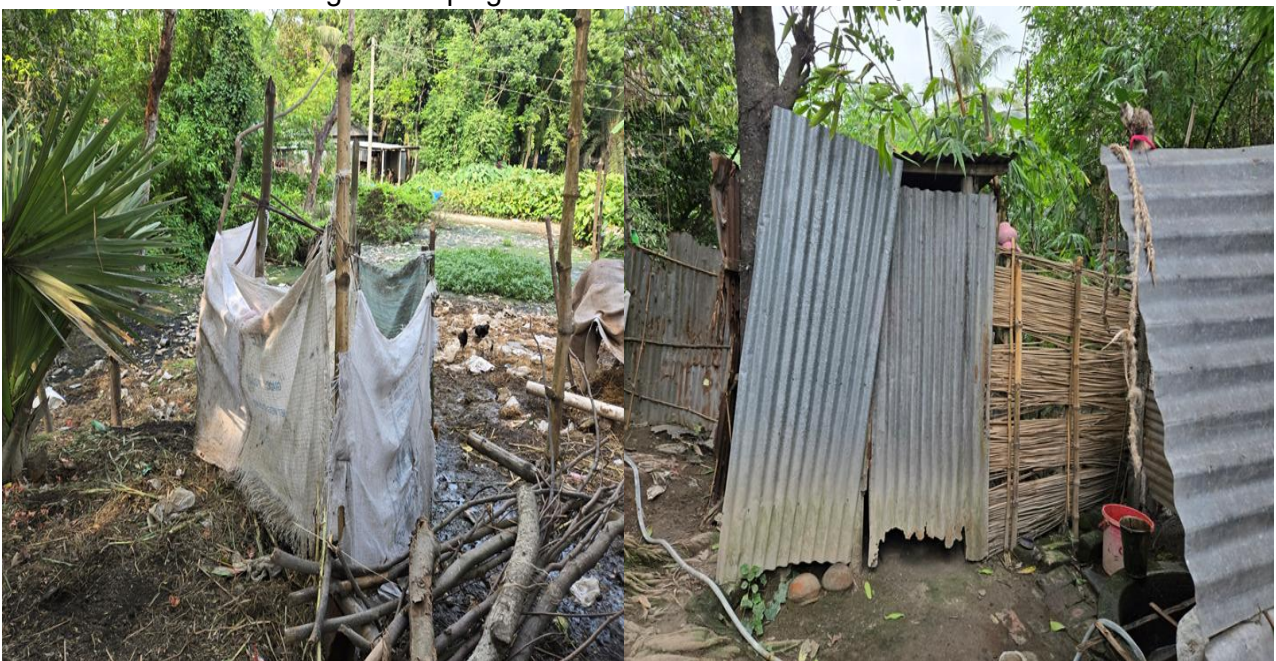
Figure IV.4: Existing Situation at Amosh Para LIN

85. The existing drains are earthen and are inactive. So, the LIN dwellers experience water logging especially during rainy season. The out fall of proposed drain is Poura secondary drain to primary drain (Section-3 site map) and because as the coming water to the proposed drain is only from rainfall run-off or household waste water. All 10 drains have been designed to be built by RCC/brick. But well-defined slopes and outfalls have been ensured. The U-type drains have been designed considering the constraint in land availability. The design life has been considered as 20 years. Integration/connection of Road side drains with the town drainage system has been considered and considering the possibilities of increased precipitation owing to probable climate change, the sections have been designed keeping allowance to accommodate 10% additional flow.

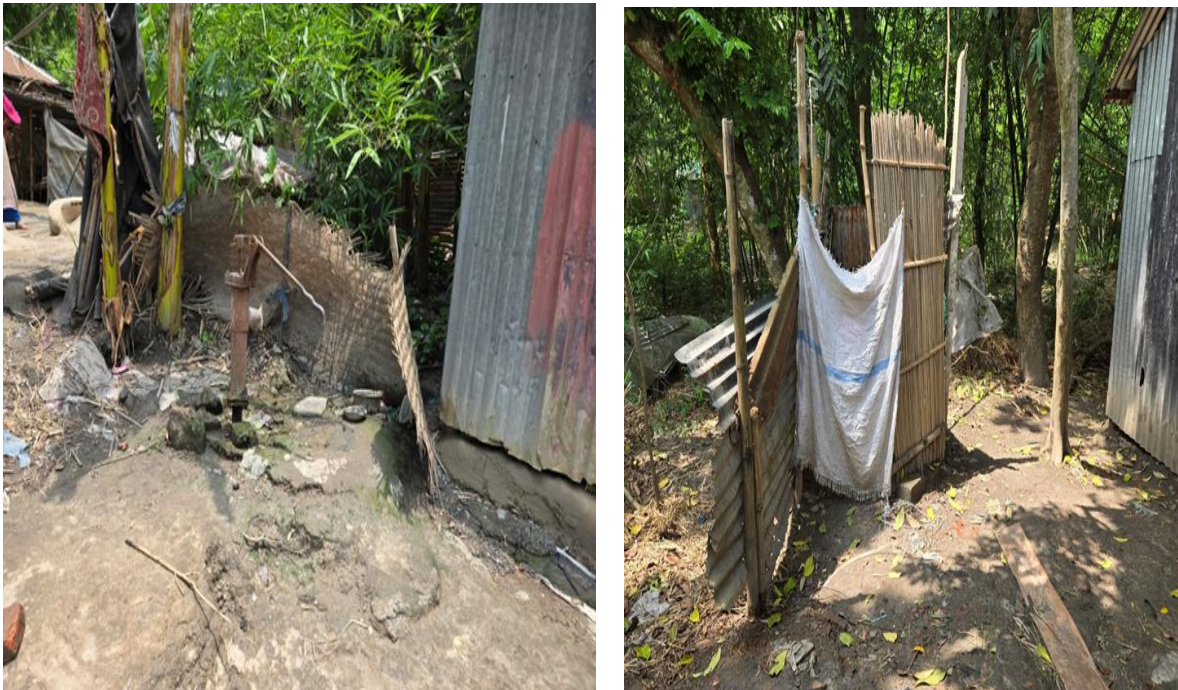
Figure 5 IV.5: Existing Situation at Gopinathpur

106. The existing drains are earthen and are inactive. So, the LIN dwellers experience water logging especially during rainy season. The out fall of proposed drain is Poura secondary drain to primary drain (Section-3 site map) and because as the coming water to the proposed drain is only from rainfall run-off or household waste water. All 10 nos slab drains have been designed to be built by RCC/brick. But well-defined slopes and outfalls have been ensured. The U-type drains have been designed considering the constraint in land availability. The design life has been considered as 20 years. Integration/connection of Road side drains with the town drainage system has been considered and considering the possibilities of increased precipitation owing to probable climate change, the sections have been designed keeping allowance to accommodate 10% additional flow.

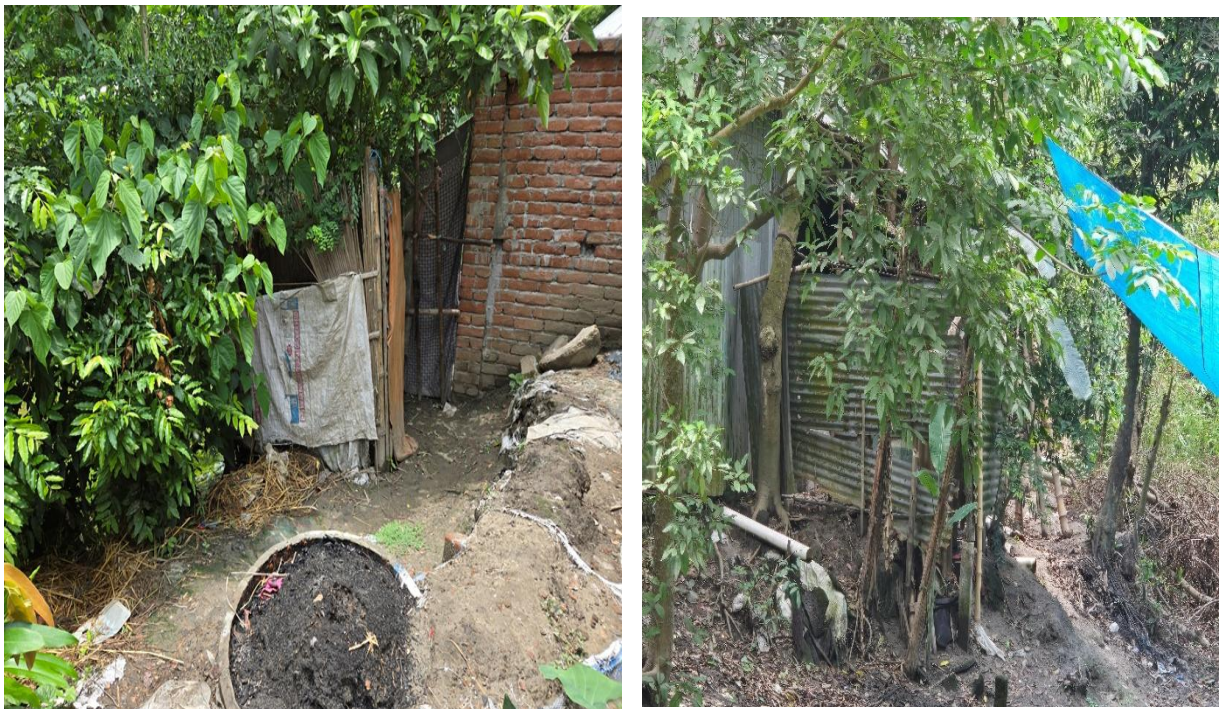
Figure 6IV.6: Existing Situation at Kazipur

122. The existing drains are earthen and are inactive. So, the LIN dwellers experience water logging especially during rainy season. The out fall of proposed drain is Poura secondary drain to primary drain (Section-3 site map) and because as the coming water to the proposed drain is only from rainfall run-off or household waste water. All drains have been designed to be built by RCC/brick. But well-defined slopes and outfalls have been ensured. The U-type drains have been designed considering the constraint in land availability. The design life has been considered as 20 years. Integration/connection of Road side drains with the town drainage system has been considered and considering the possibilities of increased precipitation owing to probable climate change, the sections have been designed keeping allowance to accommodate 10% additional flow.
