Improving Urban Governance and Infrastructure Program (IUGIP)

**Environmental Screening Report for
LIN Upgradation at Bandarban Pourashava**

Sub-Project No: IUGIP/BAND/SI/01-05/2023

JULY 2025

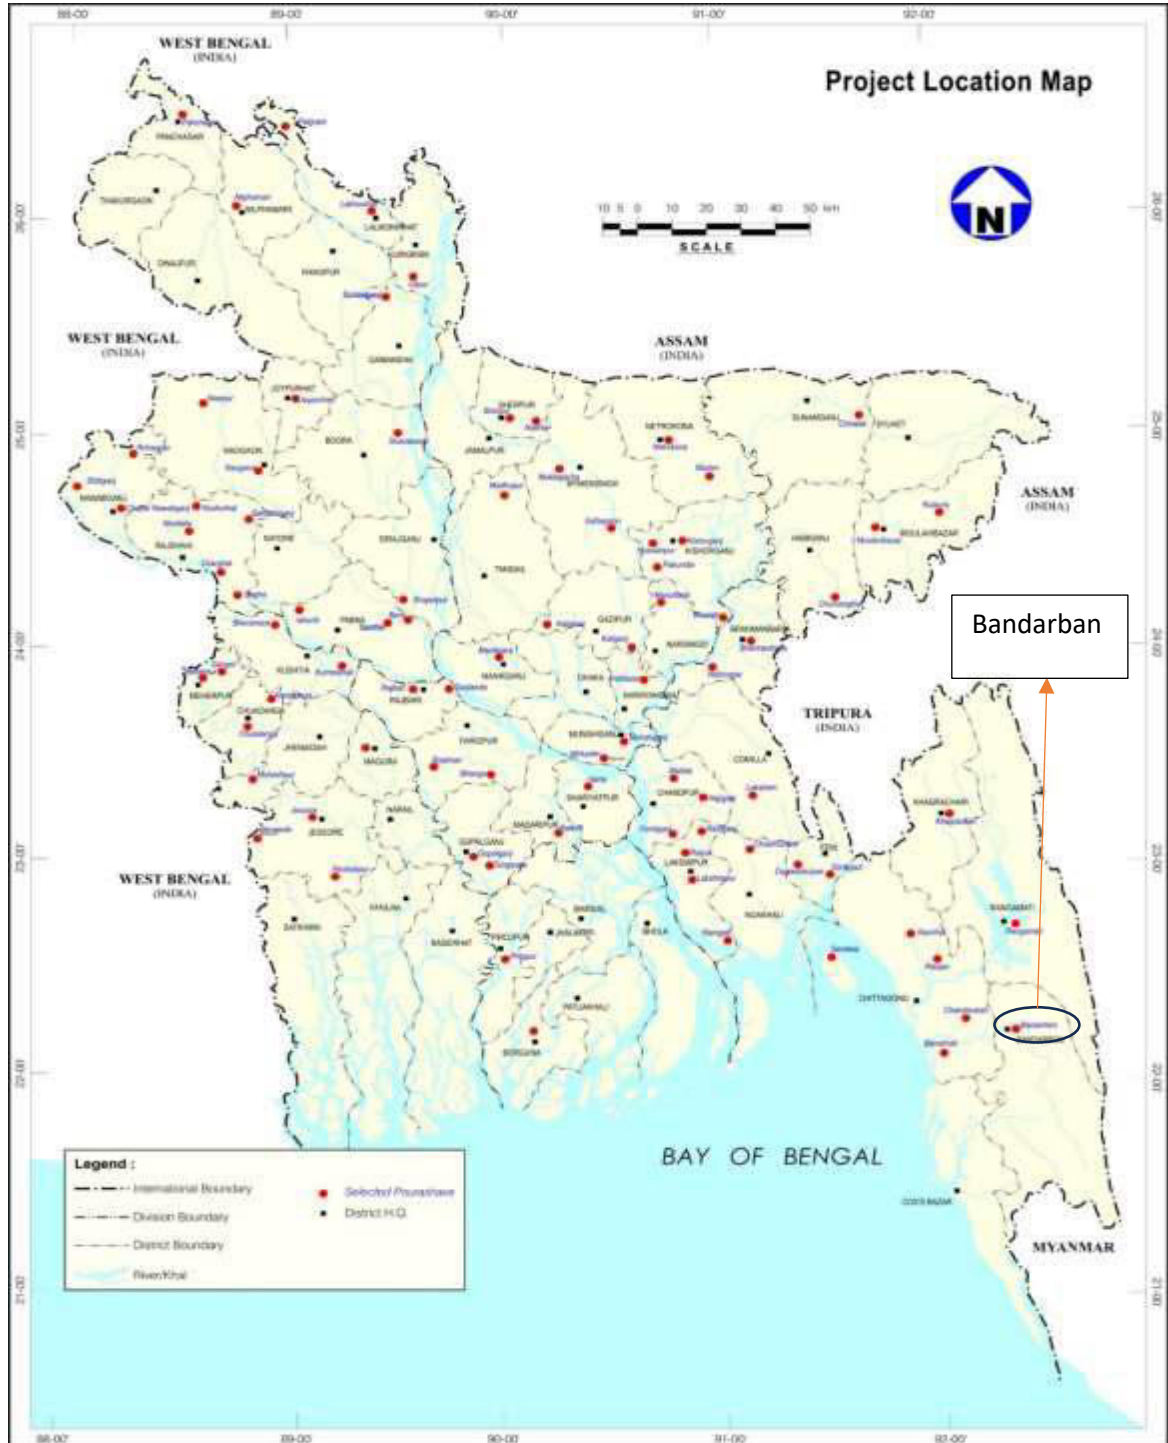
Figure I.1: Pourashava map and Location Map of Proposed LINs

screening reports on the five proposed slums in Bandarban Paurashava have been presented in this report (Hazrarmartek LIN (Lot-01), Chandabaz & Godarpar LIN (Lot-02), Sabujbag & Barishal Para LIN (Lot-03), TNT Para LIN (Lot-04), Tanki Pahar LIN (Lot-05) the location of the proposed slums **Figure I.1**.

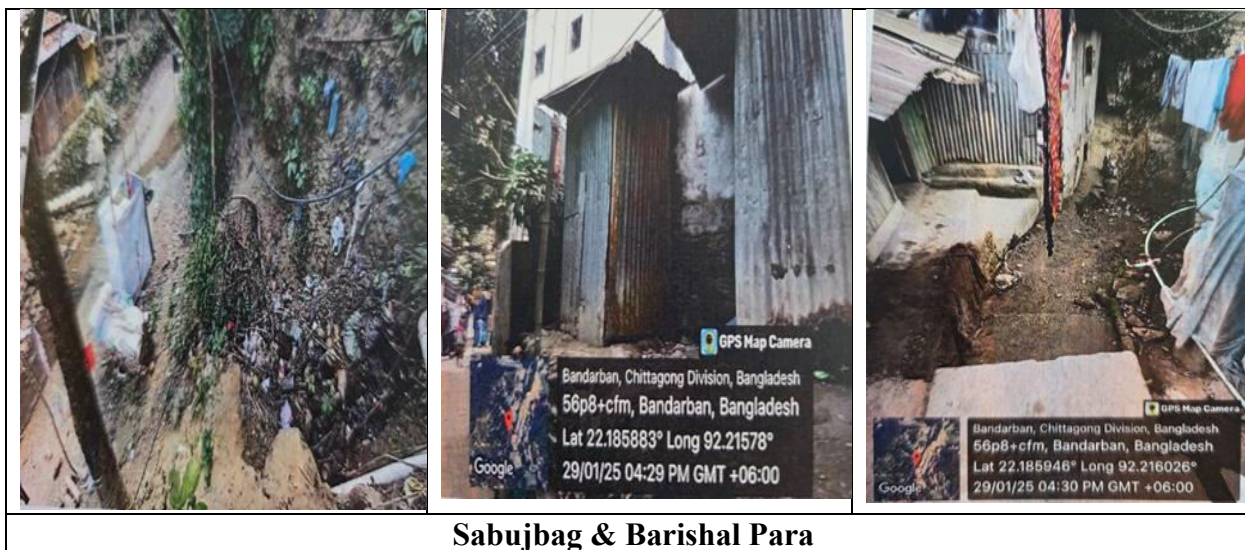
Figure IV.3: Existing Situation at Sabujbag & Barishal Para LIN

64. The existing drains are earthen and are inactive. So, the LIN dwellers experience water logging especially during rainy season. The out fall of proposed drain is Poura secondary drain to primary drain (Section-3 site map) and because as the coming water to the proposed drain is only from rainfall run-off or household waste water. All drains 150m have been designed to be built by RCC/brick. But well-defined slopes and outfalls have been ensured. The U-type drains have been designed considering the constraint in land availability. The design life has been considered as 20 years. Integration/connection of Road side drains with the town drainage system has been considered and considering the possibilities of increased precipitation owing to probable climate change, the sections have been designed keeping allowance to accommodate 10% additional flow.

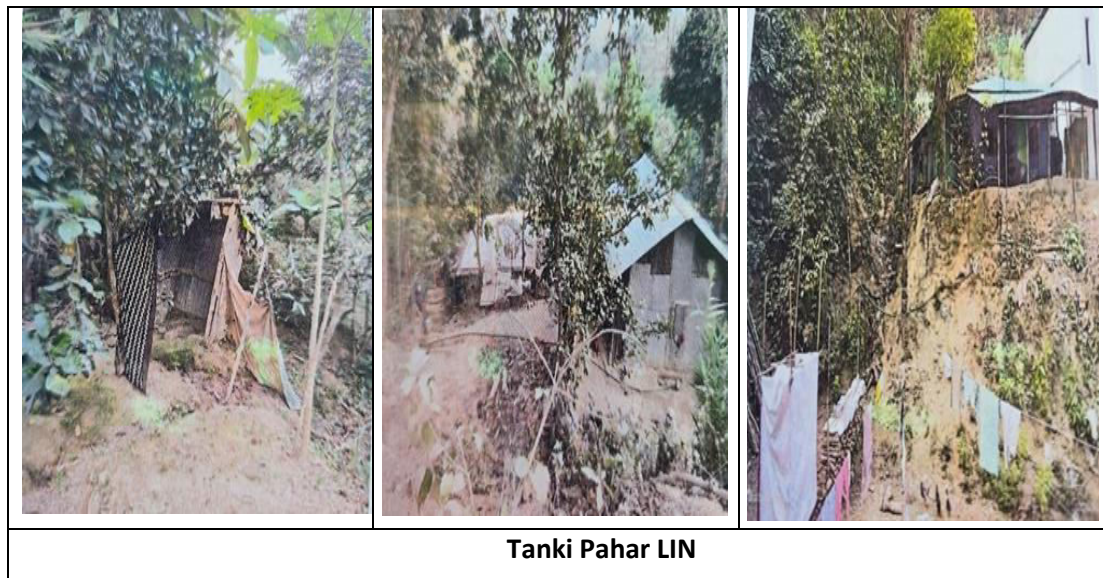
Figure IV.5: Existing Situation at Tanki Pahar LIN

109. The existing drains are earthen and are inactive. So, the LIN dwellers experience water logging especially during rainy season. The out fall of proposed drain is Poura secondary drain to primary drain (Section-3 site map) and because as the coming water to the proposed drain is only from rainfall run-off or household waste water. All drains have been designed to be built by RCC/brick. But well-defined slopes and outfalls have been ensured. The U-type drains have been designed considering the constraint in land availability. The design life has been considered as 20 years. Integration/connection of Road side drains with the town drainage system has been considered and considering the possibilities of increased precipitation owing to probable climate change, the sections have been designed keeping allowance to accommodate 10% additional flow.
