**Improving Urban Governance and Infrastructure Program (IUGIP)**

**Environmental Screening Report for  
LIN Upgradation at Bheramara Pourashava**

**Sub-Project No: IUGIP/BHER/SI/01-05/2023**

***JULY 2025***

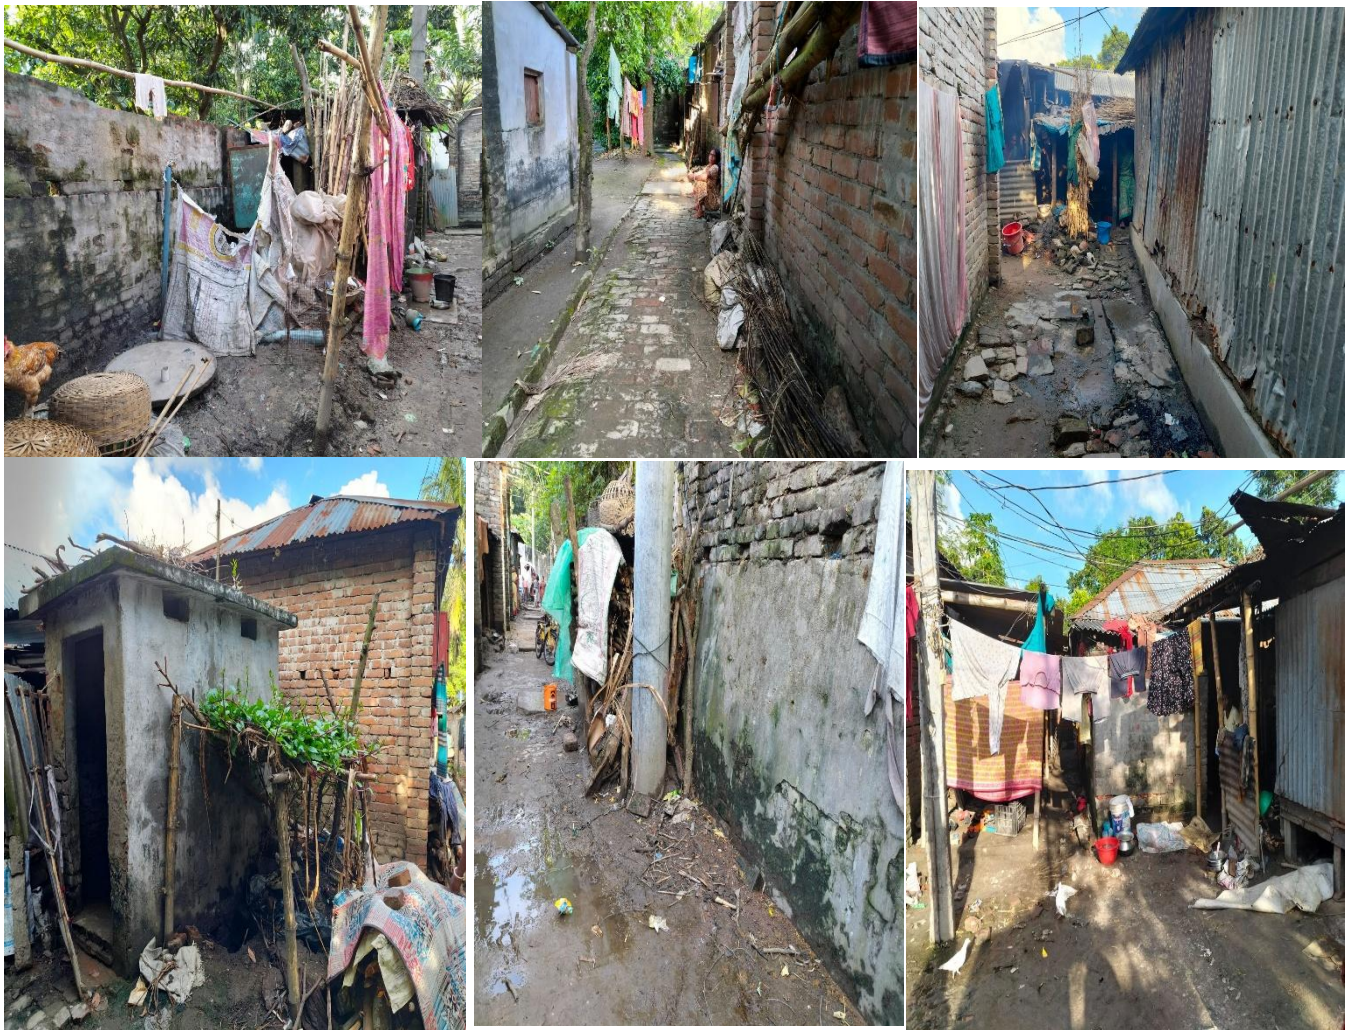
Figure IV.1: Existing Situation at Babu Para LIN

13. There is no existing sufficient sanitary toilet facility in the LIN area. LIN dwellers are facing a scarcity of hygienic sanitation; refer to **Figure II.1** for the existing condition of toilet facilities. Hence, they have demanded the construction of 15 nos. of sanitary toilets to improve the sanitation condition of their area. Refer to **Appendix 1** for the typical design of the proposed improved toilet.

14. There is no existing paved road/walkway in the LIN area. Refer to **Figure II.1** for the existing condition of access roads. LIN dwellers want 186 m of footpaths for their improved communication system within the LIN area. The proposed footpaths have been designed with cement concrete (CC) pavement over a prepared sub-base with crushed stone chips and/or Single Layer Brick Flat Soling (BFS). The LIN area is connected to Pourashava roads. A typical design of the footpath is given in **Appendix 1**.

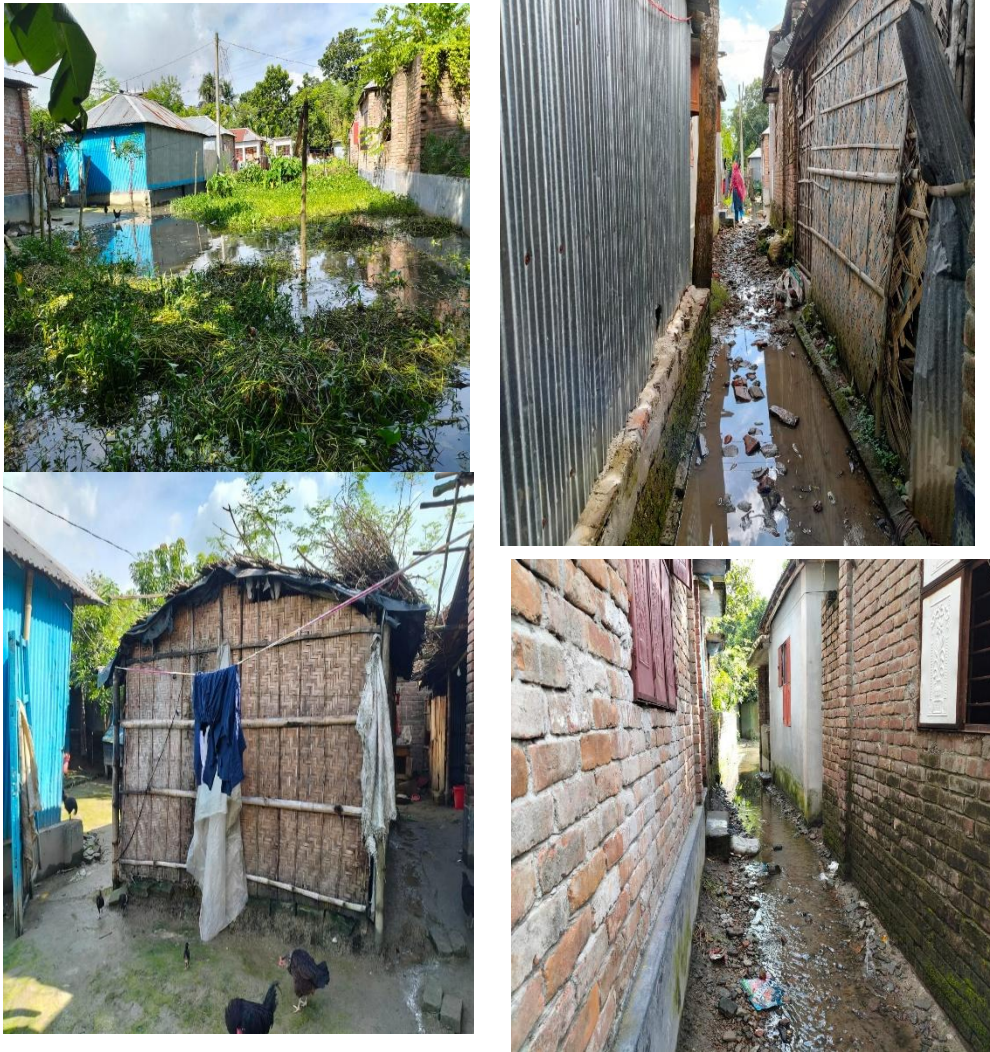
**Figure IV.2: Existing Situation at Hotath Para LIN**

33. Flood does not occur in this LIN. The existing drains are earthen and are not functioning. Water logging condition occurs due to heavy rainfall during rainy season. Rain water in the monsoon and the water coming out from bathing and washing round the year are stagnant there. As such water logging becomes a common feature there. Construction of drain is necessary in this LIN.

36. There exists earthen access road in the LIN area and no pacca walkway also in the LIN area. LIN dwellers wanted footpath for their communication within the LIN area. 130 m are being proposed in this summary. LIN area is connected by Pourashava roads. The proposed Footpaths have been designed with cement concrete (CC) crushed stone chips and over Single Layer Brick Flat Soling (BFS). LIN area is connected by Pourashava roads. Images of existing access roads of the LIN are shown in Figure II.3. Typical design of footpath is given in Appendix-1.

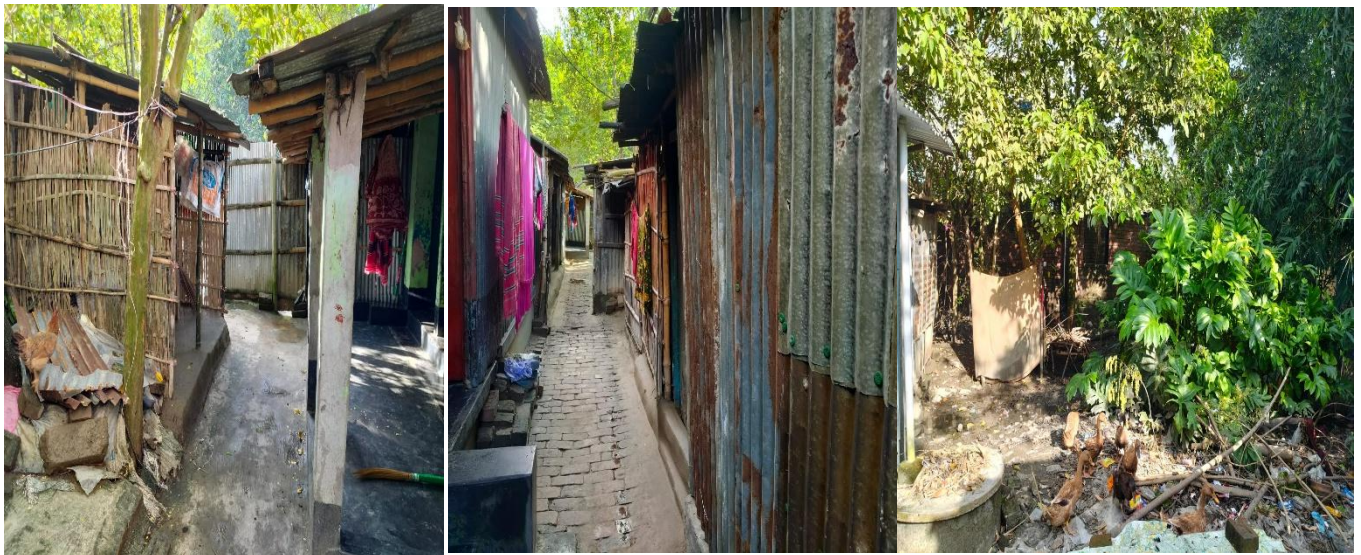
**Figure IV.3: Existing Situation at Jorina Potti LIN**

60. The existing drains are earthen and are inactive. So, the LIN dwellers experience water logging especially during rainy season. The out fall of proposed drain is Pura secondary drain to primary drain (Section-3 site map) and because as the coming water to the proposed drain is only from rainfall run-off or household waste water. All drains 314m have been designed to be built by RCC/brick. But well-defined slopes and outfalls have been ensured. The U-type drains have been designed considering the constraint in land availability. The design life has been considered as 20 years. Integration/connection of Road side drains with the town drainage system has been considered and considering the possibilities of increased precipitation owing to probable climate change, the sections have been designed keeping allowance to accommodate 10% additional flow.

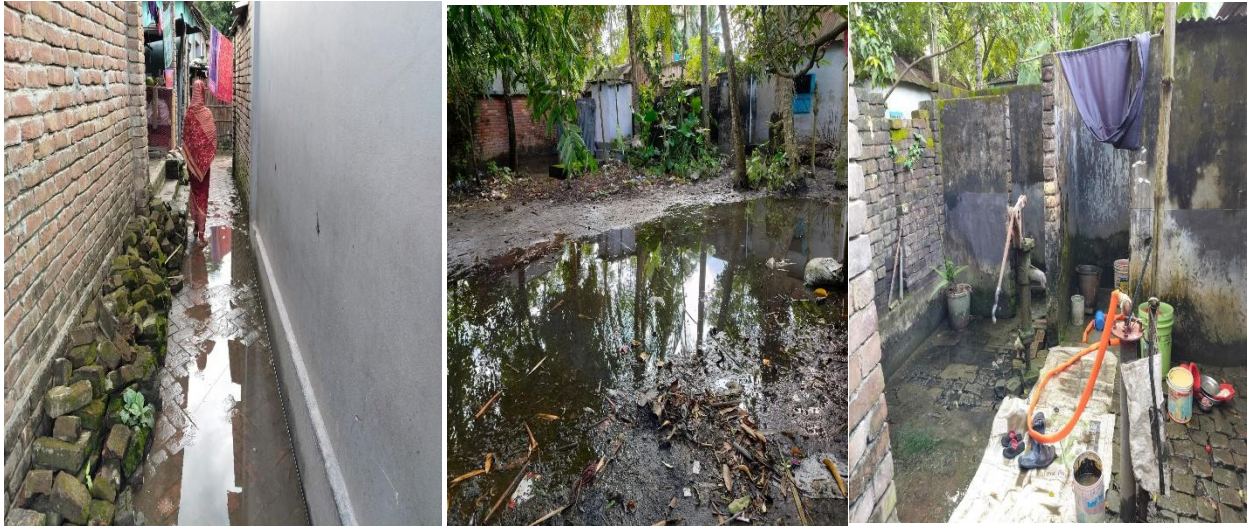
Figure IV.4: Existing Situation at Taju Para LIN

86. The existing drains are earthen and are inactive. So, the LIN dwellers experience water logging especially during rainy season. The out fall of proposed drain is Poura secondary drain to primary drain (Section-3 site map) and because as the coming water to the proposed drain is only from rainfall run-off or household waste water. All drains 194 have been designed to be built by RCC/brick. But well-defined slopes and outfalls have been ensured. The U-type drains have been designed considering the constraint in land availability. The design life has been considered as 20 years. Integration/connection of Road side drains with the town drainage system has been considered and considering the possibilities of increased precipitation owing to probable climate change, the sections have been designed keeping allowance to accommodate 10% additional flow.

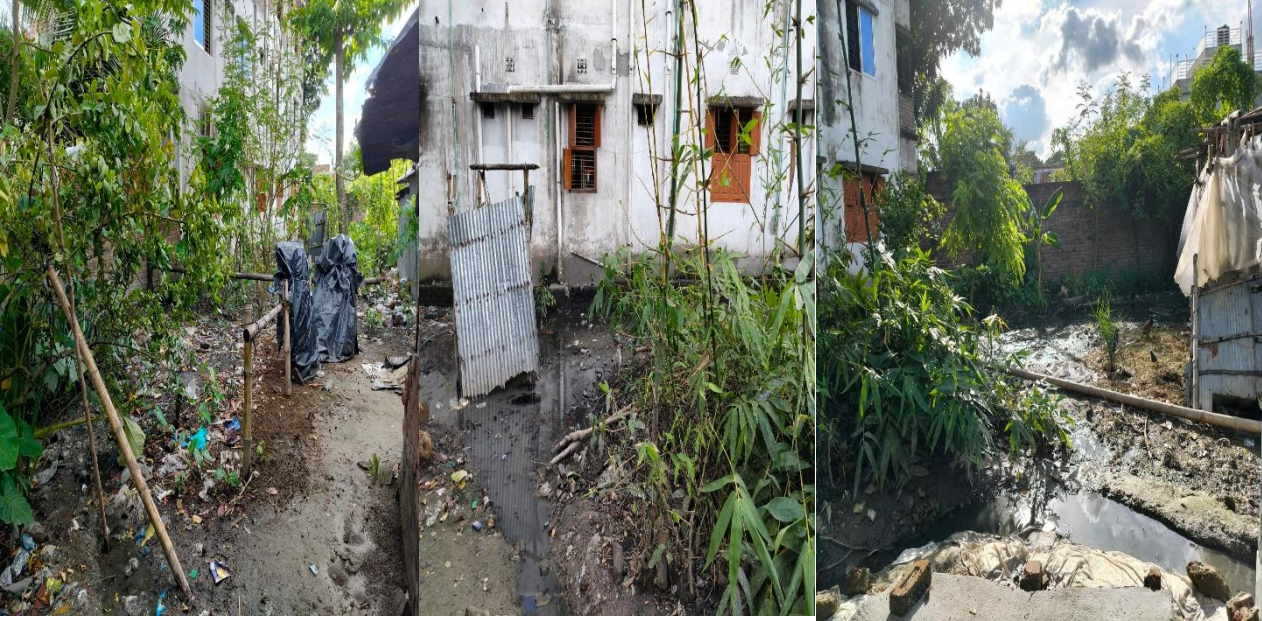
**Figure IV.5: Existing Situation at Canal para LIN**

109. The existing drains are earthen and are inactive. So, the LIN dwellers experience water logging especially during rainy season. The out fall of proposed drain is Poura secondary drain to primary drain (Section-3 site map) and because as the coming water to the proposed drain is only from rainfall run-off or household waste water. All drains 525m have been designed to be built by RCC/brick. But well-defined slopes and outfalls have been ensured. The U-type drains have been designed considering the constraint in land availability. The design life has been considered as 20 years. Integration/connection of Road side drains with the town drainage system has been considered and considering the possibilities of increased precipitation owing to probable climate change, the sections have been designed keeping allowance to accommodate 10% additional flow.
