**Improving Urban Governance and Infrastructure Program (IUGIP)**

**Environmental Screening Report for  
LIN Upgradation at Boalmari Pourashava**

**Sub-Project No: IUGIP/BOAL/SI/01-04/2023**

***JUNE 2025***

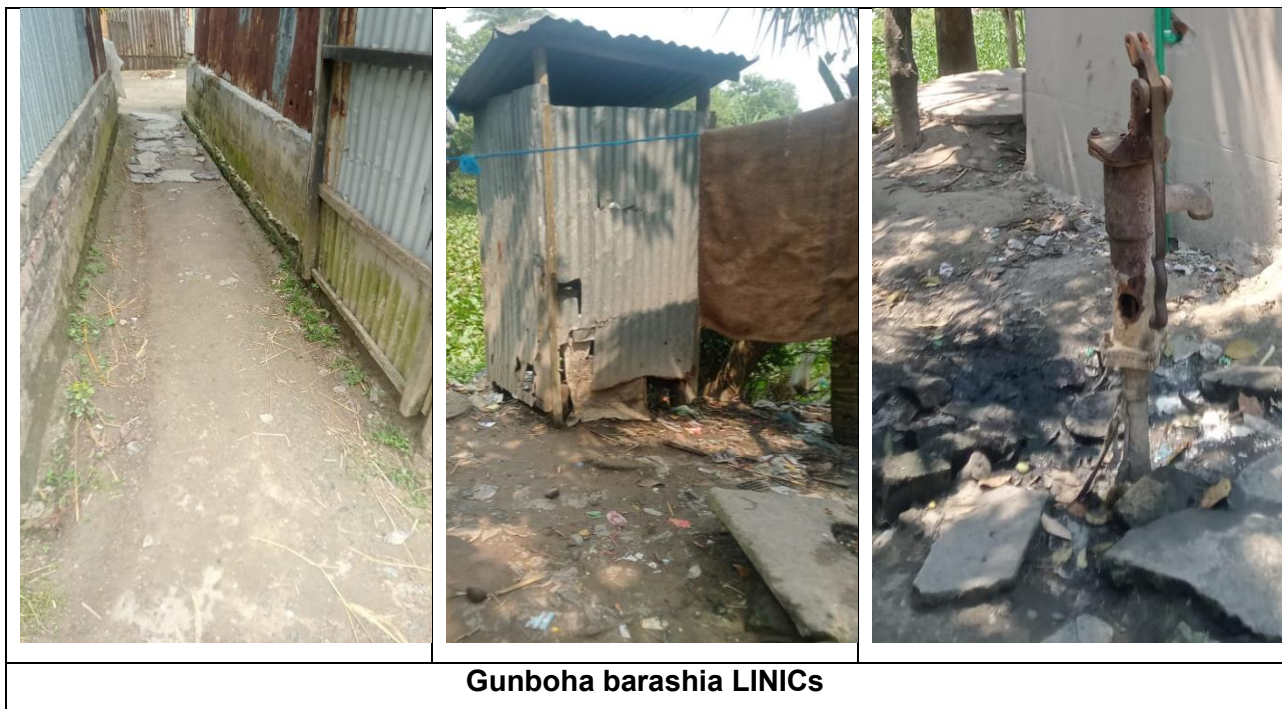
Figure IV.1: Existing Situation at Gunboha barashia LIN

13. There is no existing sufficient sanitary toilet facility in the LIN area. LIN dwellers are facing a scarcity of hygienic sanitation; refer to **Figure II.1** for the existing condition of toilet facilities. Hence, they have demanded the construction of 20 nos. of sanitary toilets to improve the sanitation condition of their area. Refer to **Appendix 1** for the typical design of the proposed improved toilet.

14. There is no existing paved road/walkway in the LIN area. Refer to **Figure II.1** for the existing condition of access roads. LIN dwellers want 320 m of footpaths for their improved communication system within the LIN area. The proposed footpaths have been designed with cement concrete (CC) pavement over a prepared sub-base with crushed stone chips and/or

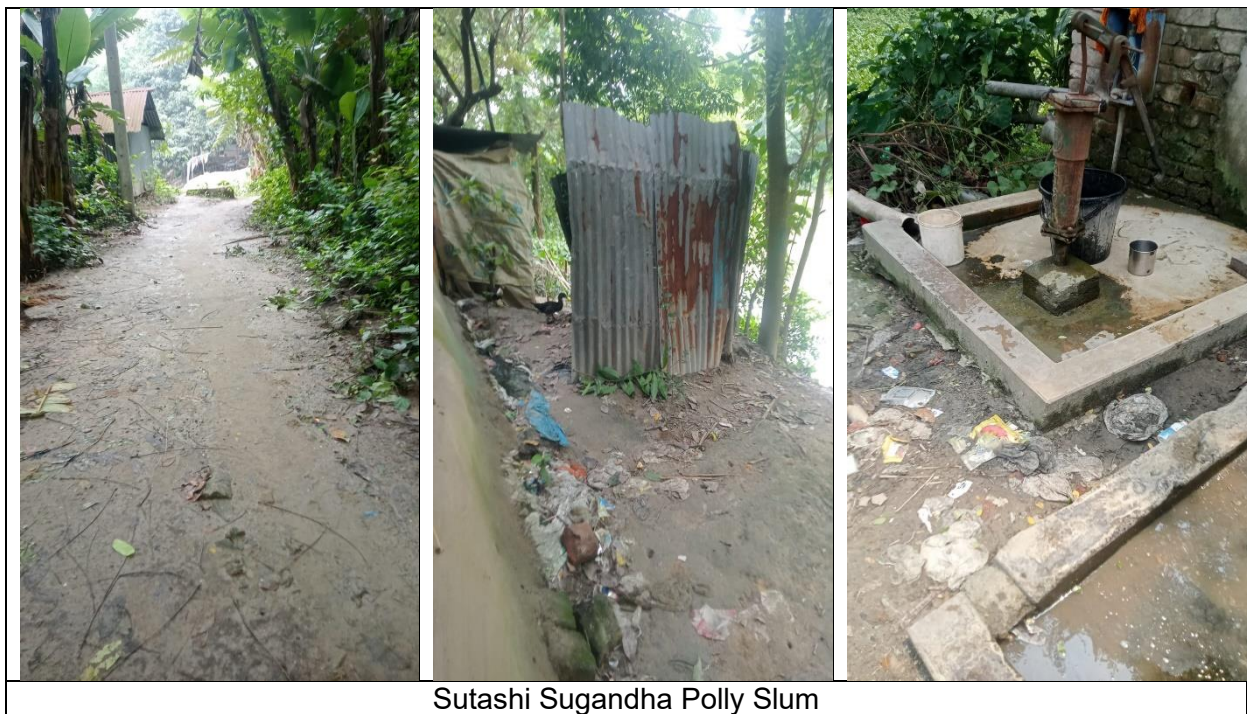
Figure IV.3: Existing Situation at Sutashi Sugandha Polly LIN

63. There are insufficient numbers of street light in this LIN area therefore 08 nos provisions of light are proposed under this package.

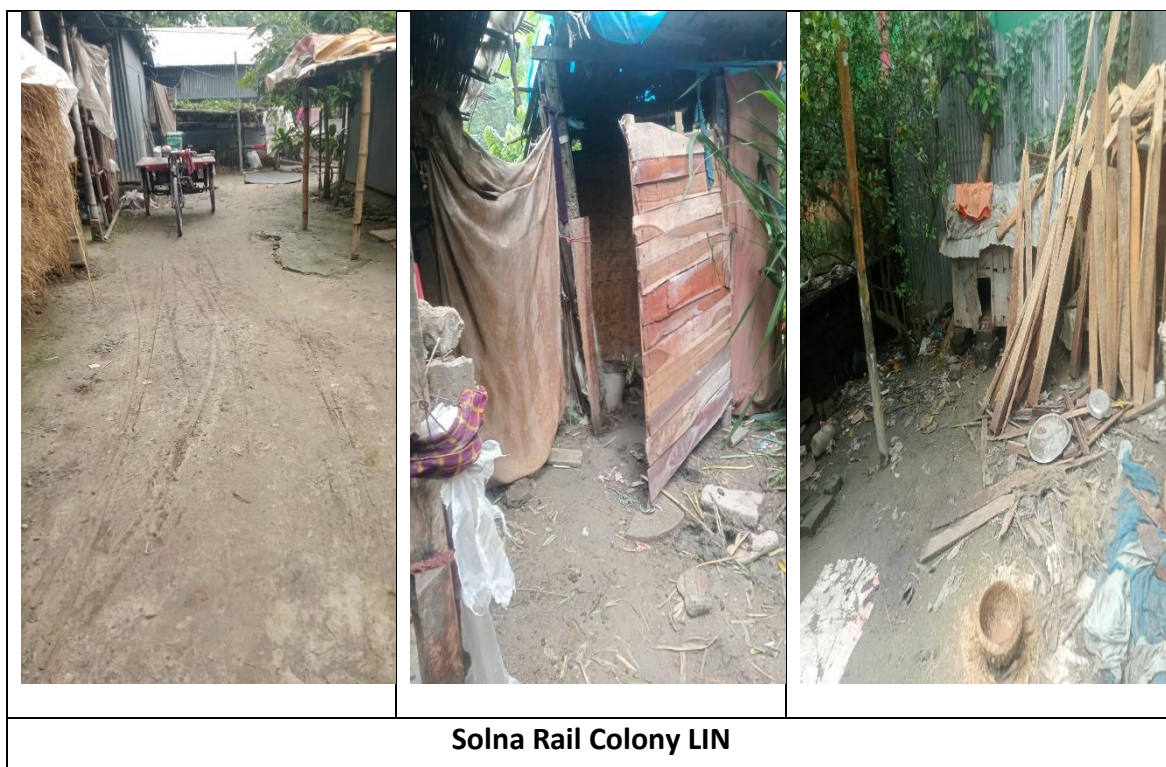
Figure IV.4: Existing Situation at Solna Rail Colony LIN

89. The existing drains are earthen and are inactive. So, the LIN dwellers experience water logging especially during rainy season. The out fall of proposed drain is Poura secondary drain to primary drain (Section-3 site map) and because as the coming water to the proposed drain is only from rainfall run-off or household waste water. But well-defined slopes and outfalls have been ensured. The U-type drains have been designed considering the constraint in land availability. The design life has been considered as 20 years. Integration/connection of Road side drains with the town drainage system has been considered and considering the possibilities of increased precipitation owing to probable climate change, the sections have been designed keeping allowance to accommodate 10% additional flow.
