Improving Urban Governance and Infrastructure Program (IUGIP)

**Environmental Screening Report for
LIN Upgradation at Brahmanbaria Pourashava**

Sub-Project No: IUGIP/BRAH/SI/01-05/2023

AUGUST 2025

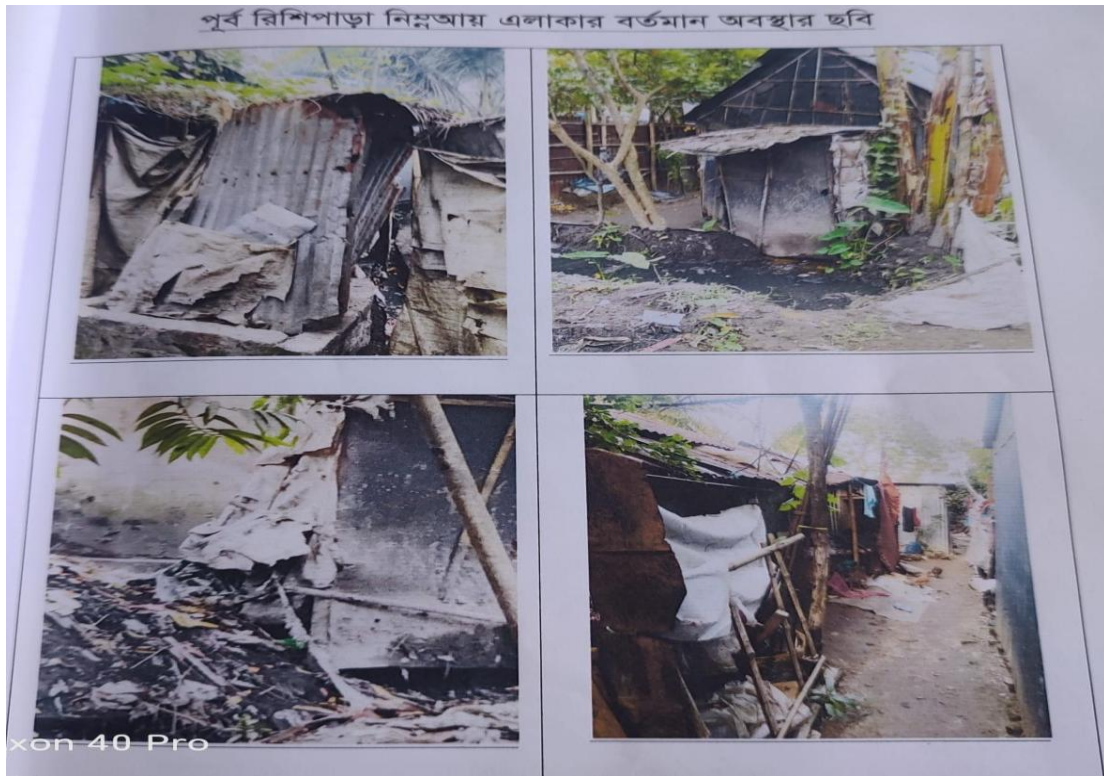
Figure IV.1: Existing Situation Purbo Rishi Para LIN

9. Flood does not occur in this slum. There exist no paved internal drainage systems in the slums. The existing drains are earthen that are poorly functioning. As the LIN areas are low-lying, heavy rainfall during the rainy season creates water logging. Hence, the construction of drains is necessary to remove water logging conditions in these LINs.

11. There is no existing sufficient sanitary toilet facility in the LIN area. LIN dwellers are facing a scarcity of hygienic sanitation; refer to **Figure II.1** for the existing condition of toilet facilities. Hence, they have demanded the construction of 23 nos. of sanitary toilets to improve the sanitation condition of their area. Refer to **Appendix 1** for the typical design of the proposed improved toilet.

12. There is no existing paved road/walkway in the LIN area. Refer to **Figure II.1** for the existing condition of access roads. LIN dwellers want 291m of footpaths for their improved communication system within the LIN area. The proposed footpaths have been designed with cement concrete (CC) pavement over a prepared sub-base with crushed stone chips and/or Single Layer Brick Flat Soling (BFS). The LIN area is connected to Pourashava roads. A typical design of the footpath is given in **Appendix 1**.

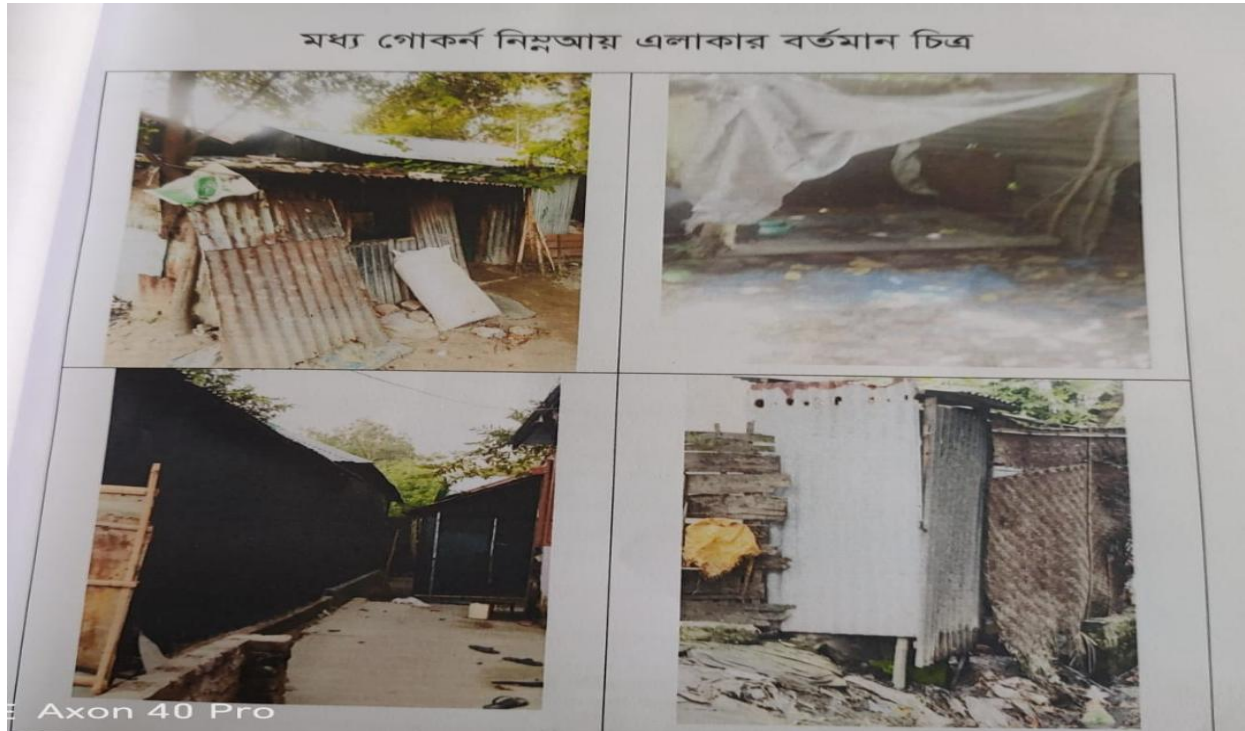
Figure IV.2: Existing Situation at Moddhogokorno LIN (Lot-02)

30. Flood does not occur in this LIN. The existing drains are earthen and are not functioning. Water logging condition occurs due to heavy rainfall during rainy season. Rain water in the monsoon and the water coming out from bathing and washing round the year are stagnant there. As such water logging becomes a common feature there. Construction of drain is necessary in this LIN.

33. There exists earthen access road in the LIN area and no pacca walkway also in the LIN area. LIN dwellers wanted footpath for their communication within the LIN area. 298 m are being proposed in this summary. LIN area is connected by Pourashava roads. The proposed

Footpaths have been designed with cement concrete (CC) crushed stone chips and over Single Layer Brick Flat Soling (BFS). LIN area is connected by Pourashava roads. Images of existing access roads of the LIN are shown in Figure II.3. Typical design of footpath is given in Appendix-1.

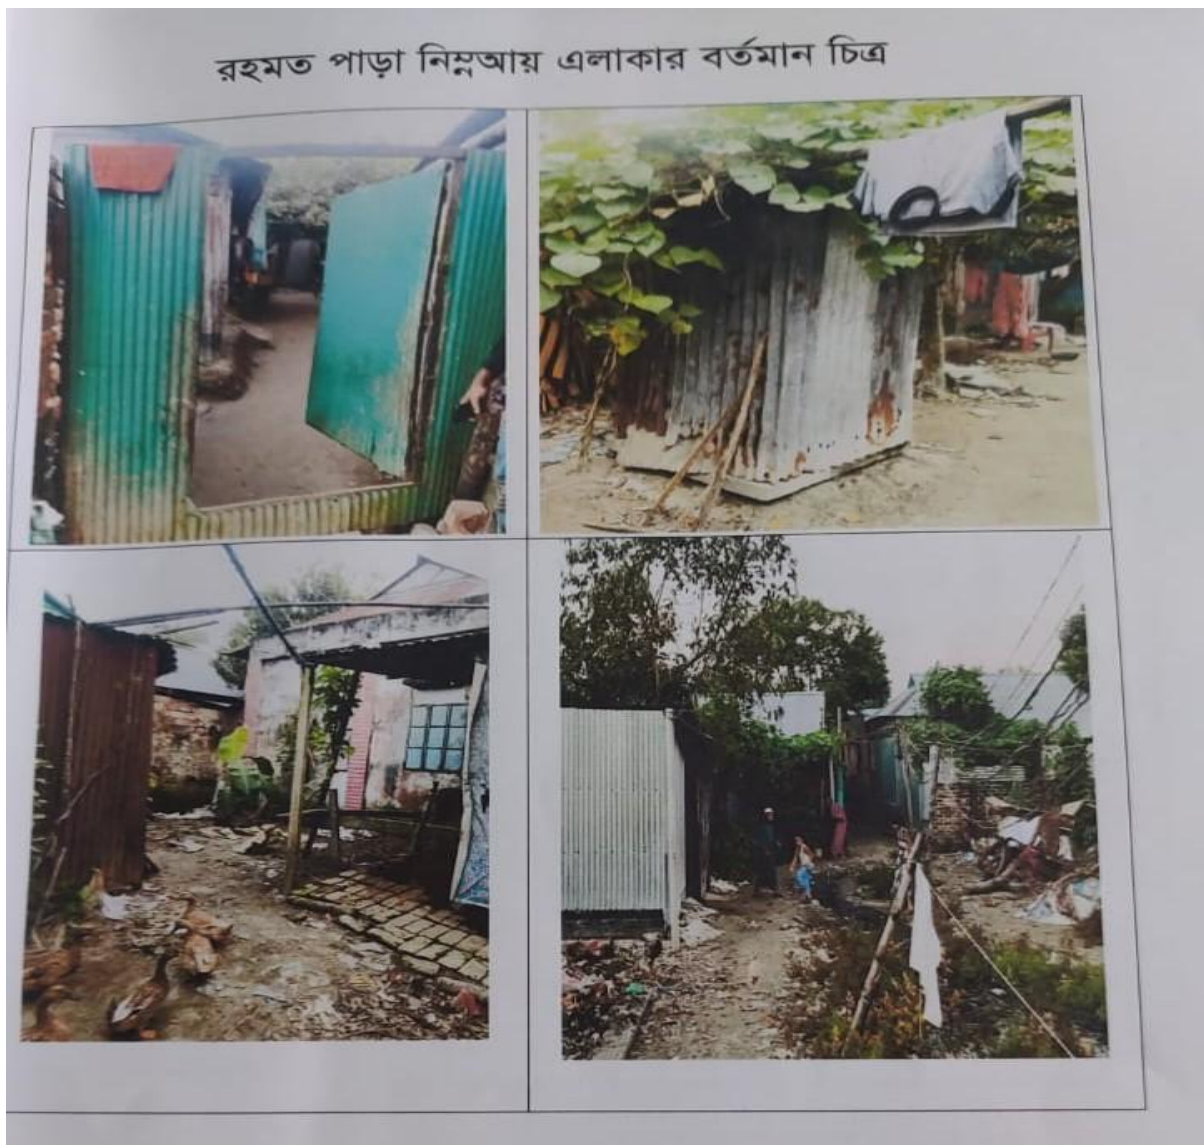
Figure IV.3: Existing Situation of Drain at Rohomot LIN

56. The existing drains are earthen and are inactive. So, the LIN dwellers experience water logging especially during rainy season. The out fall of proposed drain is Poura secondary drain to primary drain (Section-3 site map) and because as the coming water to the proposed drain is only from rainfall run-off or household waste water. All drains 240m have been designed to be built by RCC/brick. But well-defined slopes and outfalls have been ensured. The U-type drains have been designed considering the constraint in land availability. The design life has been considered as 20 years. Integration/connection of Road side drains with the town drainage system has been considered and considering the possibilities of increased precipitation owing to probable climate change, the sections have been designed keeping allowance to accommodate 10% additional flow.

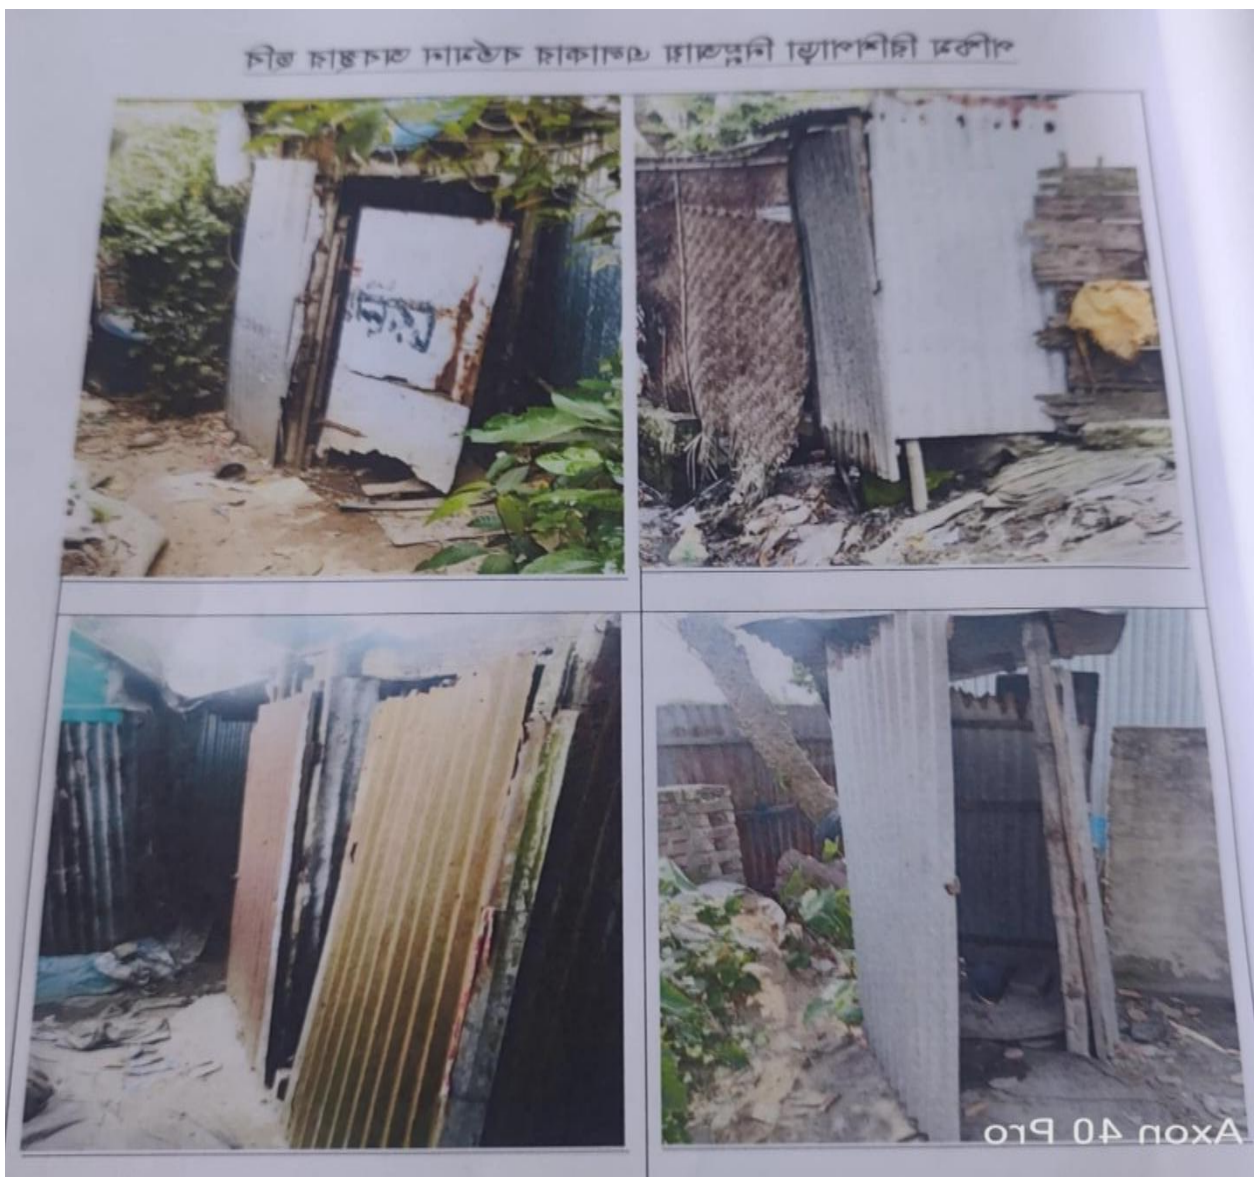
Figure IV.4: Existing Situation at Paschim Rishi Para LIN

The existing drains are earthen and are inactive. So, the LIN dwellers experience water logging especially during rainy season. The out fall of proposed drain is Poura secondary drain to primary drain (Section-3 site map) and because as the coming water to the proposed drain is only from rainfall run-off or household waste water. All drains have been designed to be built by RCC/brick. But well-defined slopes and outfalls have been ensured. The U-type drains have been designed considering the constraint in land availability. The design life has been considered as 20 years. Integration/connection of Road side drains with the town drainage system has been considered and considering the possibilities of increased precipitation owing to probable climate change, the sections have been designed keeping allowance to accommodate 10% additional flow.

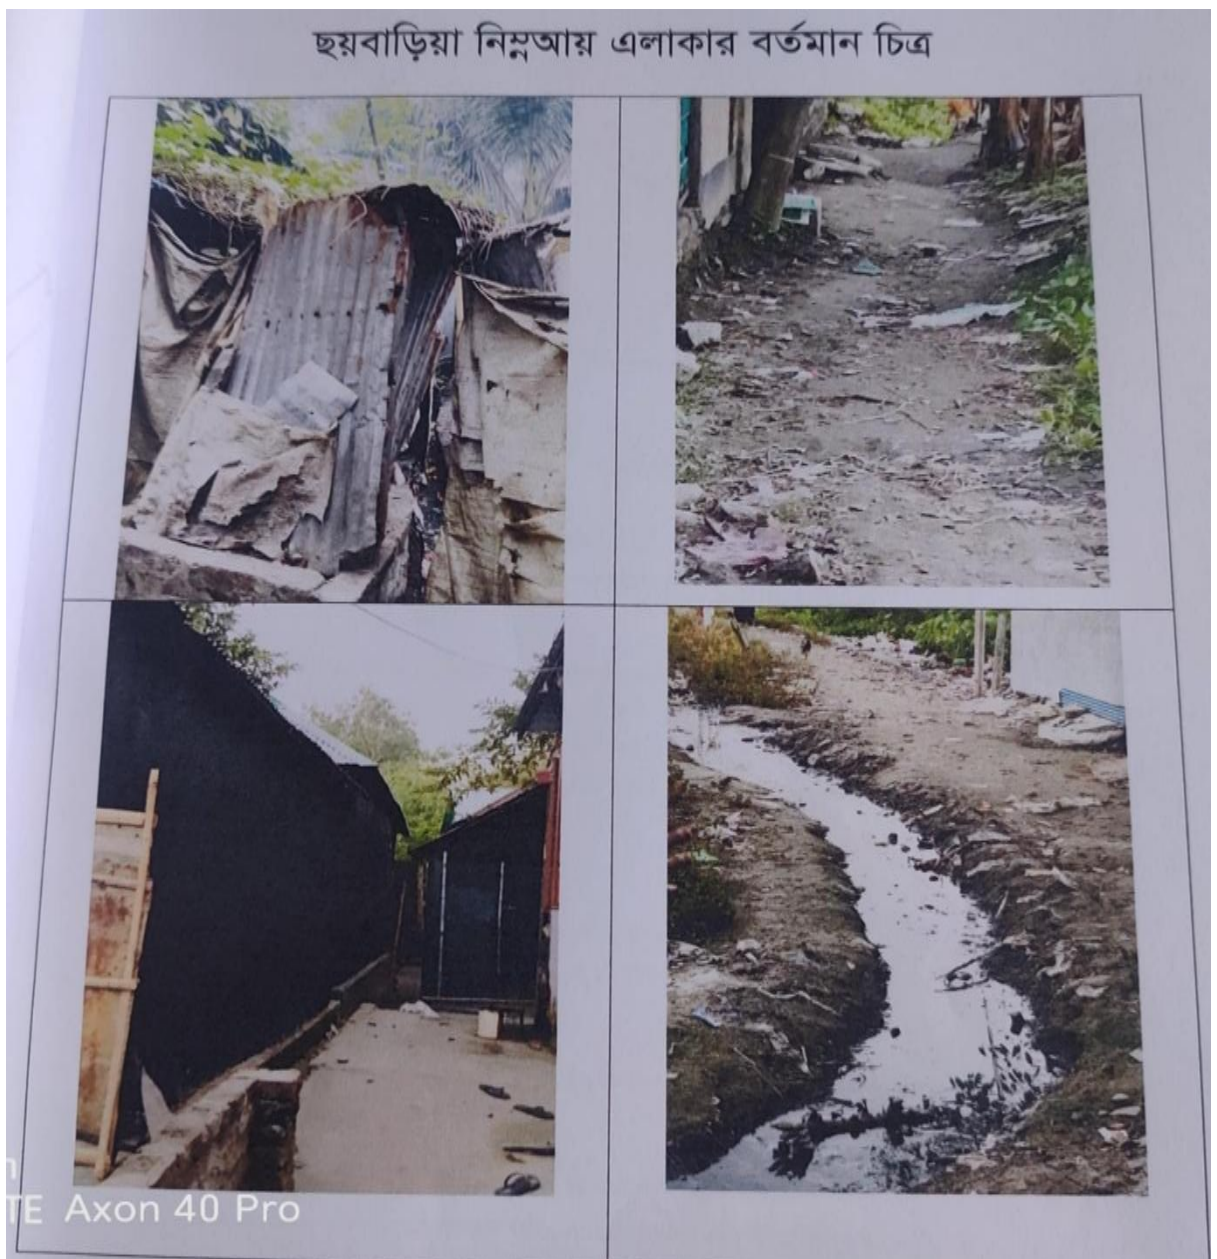
Figure IV.5: Existing Situation at Choybaria Gram LIN

The existing drains are earthen and are inactive. So, the LIN dwellers experience water logging especially during rainy season. The out fall of proposed drain is Poura secondary drain to primary drain (Section-3 site map) and because as the coming water to the proposed drain is only from rainfall run-off or household waste water. All drains (125m)have been designed to be built by RCC/brick. But well-defined slopes and outfalls have been ensured. The U-type drains have been designed considering the constraint in land availability. The design life has been considered as 20 years. Integration/connection of Road side drains with the town drainage system has been considered and considering the possibilities of increased precipitation owing to probable climate change, the sections have been designed keeping allowance to accommodate 10% additional flow.
