Improving Urban Governance and Infrastructure Program (IUGIP)

**Environmental Screening Report for
LIN Upgradation at CHARGHAT Pourashava**

Sub-Project No: IUGIP/CHAR/SI/01-05/2023

SEPTEMBER 2025

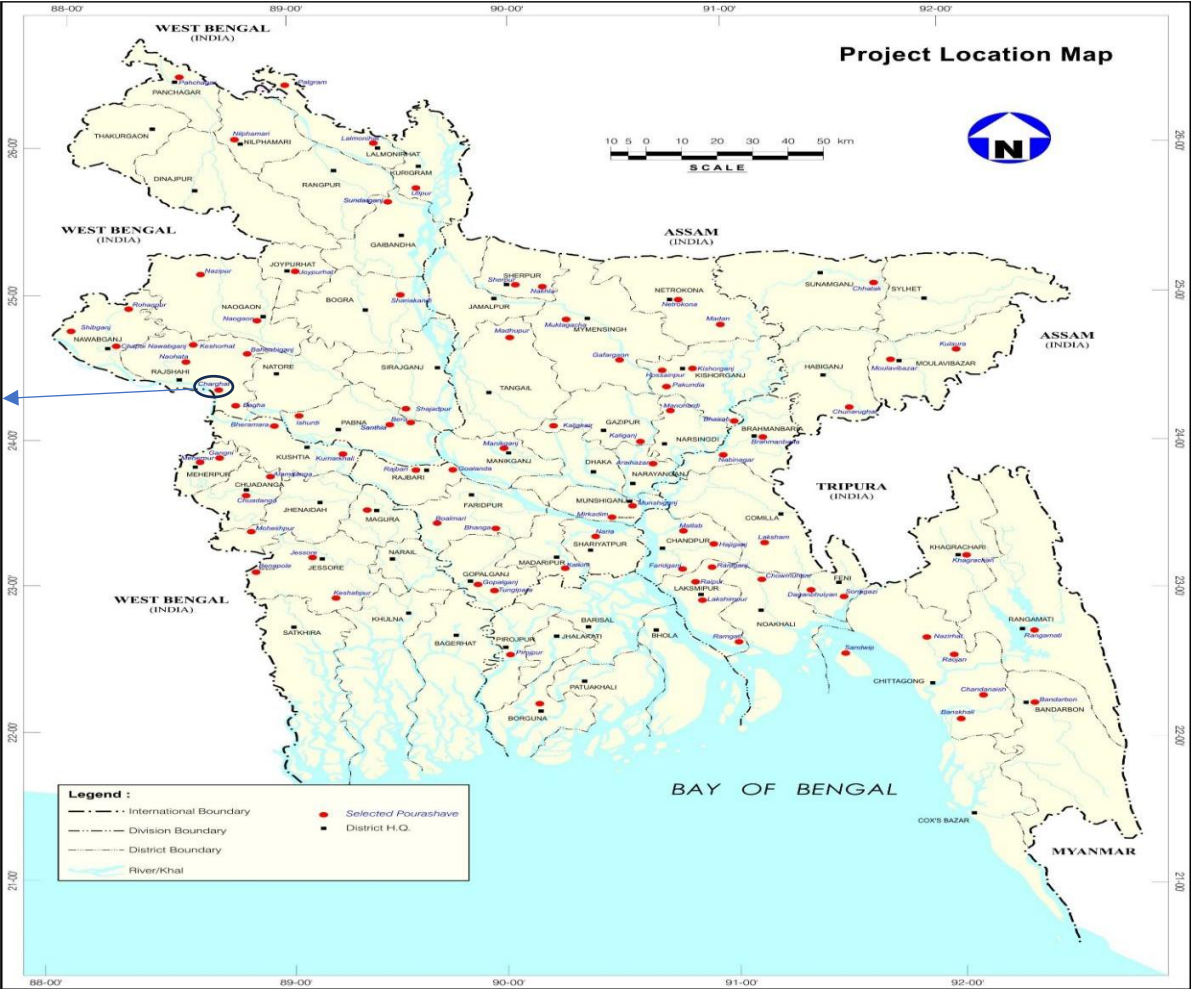
Figure I.1: Pourashava Map and Location Map of Proposed LINs

7. Total slums 05 (Five) slums have been included in the Sub-project under discussion for providing infrastructure facilities in the selected slums and improving the environment. Environmental screening reports on the five proposed slums in Charghat Paurashava have been presented in this report Mukterpur Mondol para-LIN (Lot-01), Gourshohorpur Notun para-LIN (Lot-02), Miyapur Uttar & Dakkhin LIN (Lot-03), Thanapara Moddhopara & Mathpara LIN (Lot-04), Gopalpur Gorsthanpara LIN (Lot-05) the location of the proposed slums **Figure I.1**.

9. The Mukterpur LIN is situated in ward no. 2 under charchat Paurashava of charchat Upazila under Rajshahi District; refer to Figure I.1 for the location of the slum in the Charchat Paurashava map.

75. The Thanapara Moddhopara & Mathpara (Lot-04) is situated in ward no. 05 under charghat Paurashava of charghat Upazila under Rajshahi District; refer to Figure I.1 for the location of the LIN in the charghat Paurashava map.

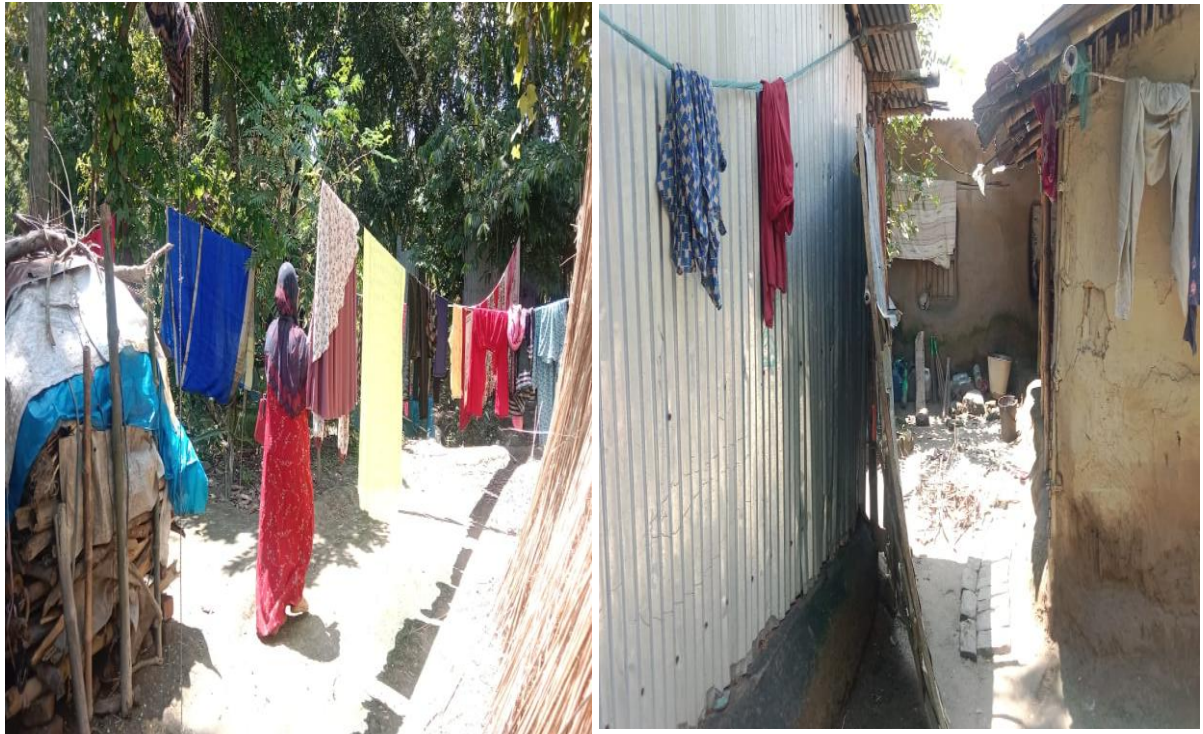
Figure IV.1: Existing Situation Purbo Rishi Para LIN

13. There is no existing sufficient sanitary toilet facility in the LIN area. LIN dwellers are facing a scarcity of hygienic sanitation; refer to **Figure II.1** for the existing condition of toilet facilities. Hence, they have demanded the construction of 15 nos. of sanitary toilets to improve the sanitation condition of their area. Refer to **Appendix 1** for the typical design of the proposed improved toilet.

14. There is no existing paved road/walkway in the LIN area. Refer to **Figure II.1** for the existing condition of access roads. LIN dwellers want 771m of footpaths for their improved communication system within the LIN area. The proposed footpaths have been designed with cement concrete (CC) pavement over a prepared sub-base with crushed stone chips and/or Single Layer Brick Flat Soling (BFS). The LIN area is connected to Pourashava roads. A typical design of the footpath is given in **Appendix 1**.

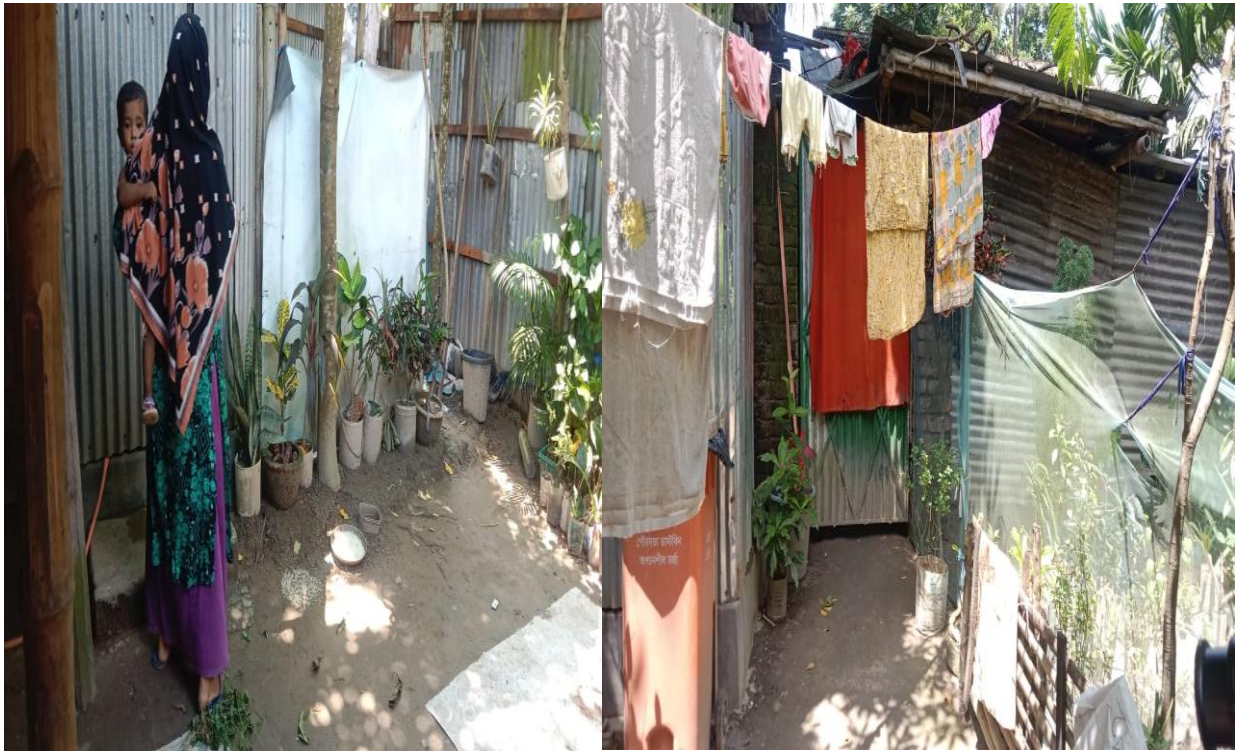
Figure IV.2: Existing Situation at Gourshohorpur Notun para (Lot-02)

36. There exists earthen access road in the LIN area and no pacca walkway also in the LIN area. LIN dwellers wanted footpath for their communication within the LIN area. 329 m are being proposed in this summary. LIN area is connected by Pourashava roads. The proposed Footpaths have been designed with cement concrete (CC) crushed stone chips and over Single Layer Brick Flat Soling (BFS). LIN area is connected by Pourashava roads. Images of

existing access roads of the LIN are shown in Figure II.3. Typical design of footpath is given in Appendix-1.

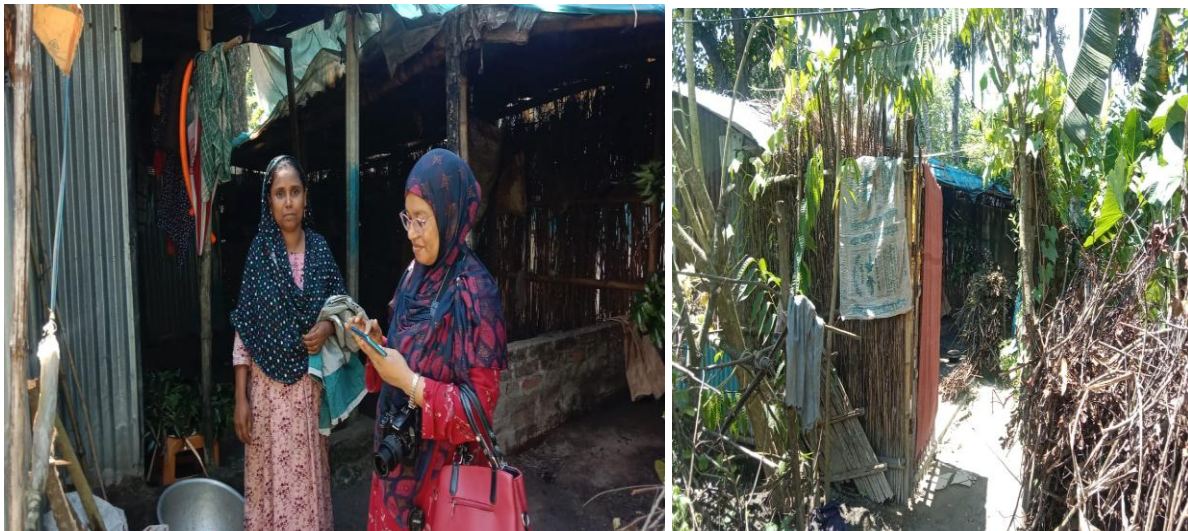
Figure IV.3: Existing Situation at for Miyapur Uttar & Dakkhin para (Lot-03)

59. The existing drains are earthen and are inactive. So, the LIN dwellers experience water logging especially during rainy season. The out fall of proposed drain is Poura secondary drain to primary drain (Section-3 site map) and because as the coming water to the proposed drain is only from rainfall run-off or household waste water. All drains 78m have been designed to be built by RCC/brick. But well-defined slopes and outfalls have been ensured. The U-type drains have been designed considering the constraint in land availability. The design life has been considered as 20 years. Integration/connection of Road side drains with the town drainage system has been considered and considering the possibilities of increased precipitation owing to probable climate change, the sections have been designed keeping allowance to accommodate 10% additional flow.

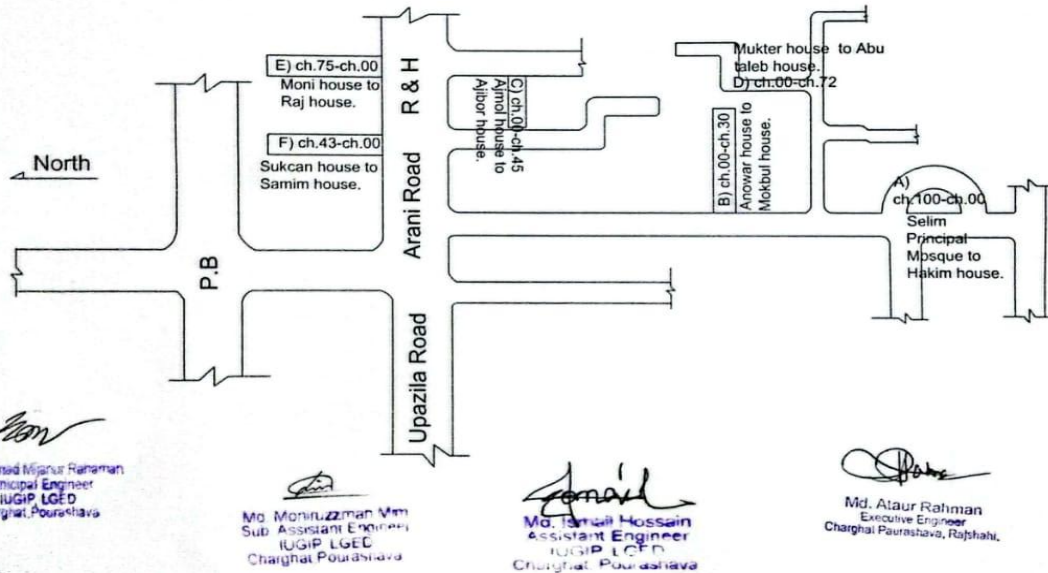
d. Site Map of the Miyapur Uttar & Dakkhin LIN

Miyapur Uttor & Dhokkin Linic:-03
Word No:-07
Footpath Location Map:

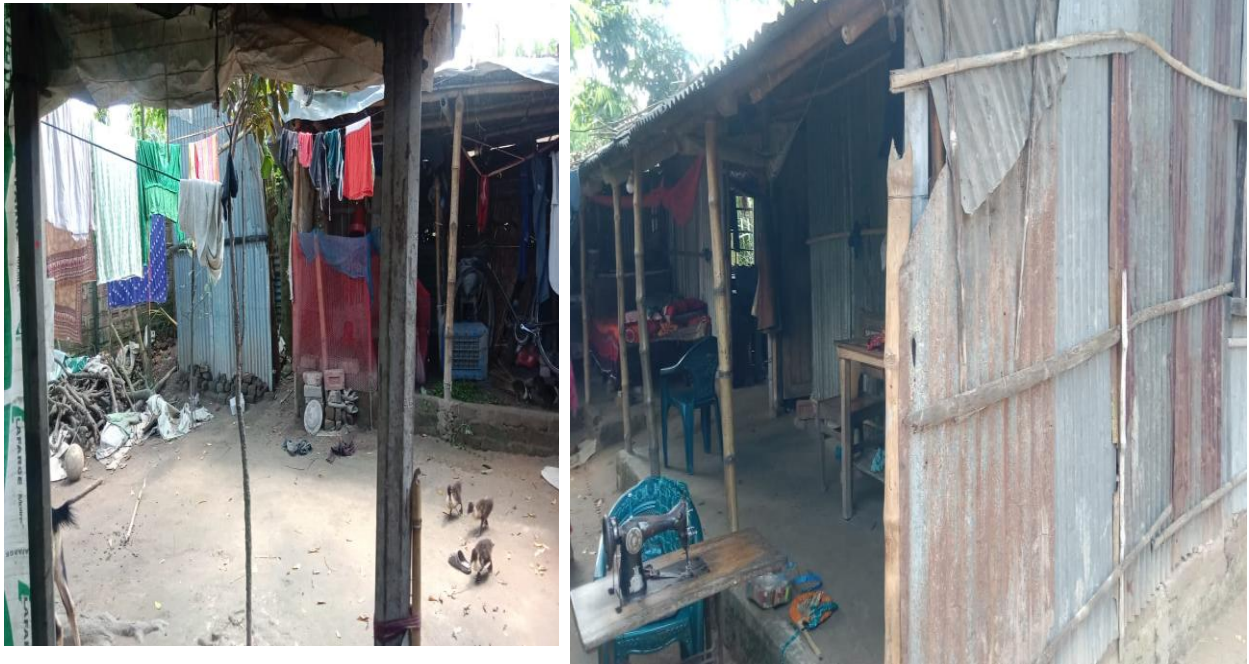
Figure IV.3: Existing Situation at Paschim Rishi Para LIN

The existing drains are earthen and are inactive. So, the LIN dwellers experience water logging especially during rainy season. The out fall of proposed drain is Poura secondary drain to primary drain (Section-3 site map) and because as the coming water to the proposed drain is only from rainfall run-off or household waste water. All drains 50m have been designed to be built by RCC/brick. But well-defined slopes and outfalls have been ensured. The U-type drains have been designed considering the constraint in land availability. The design life has been considered as 20 years. Integration/connection of Road side drains with the town drainage system has been considered and considering the possibilities of increased precipitation owing to probable climate change, the sections have been designed keeping allowance to accommodate 10% additional flow.

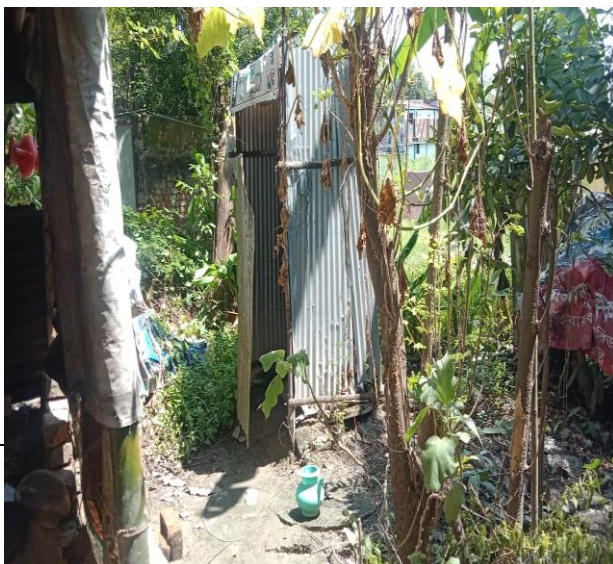
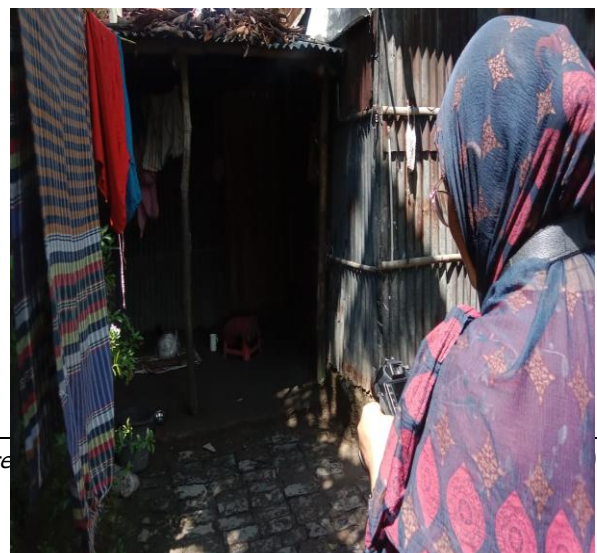
Figure IV.4: Existing Situation at Gopalpur Gorsthanpara LIN

The existing drains are earthen and are inactive. So, the LIN dwellers experience water logging especially during rainy season. The out fall of proposed drain is Poura secondary drain to primary drain (Section-3 site map) and because as the coming water to the proposed drain is only from rainfall run-off or household waste water. All drains (35m) have been designed to be built by RCC/brick. But well-defined slopes and outfalls have been ensured. The U-type drains have been designed considering the constraint in land availability. The design life has been considered as 20 years. Integration/connection of Road side drains with the town drainage system has been considered and considering the possibilities of increased precipitation owing to probable climate change, the sections have been designed keeping allowance to accommodate 10% additional flow.
