**Improving Urban Governance and Infrastructure Program (IUGIP)**

**Environmental Screening Report for  
LIN Upgradation at Daganbhuiyan Pourashava**

**Sub-Project No: IUGIP/DAGA/SI/01-04/2023**

**DECEMBER 2024**

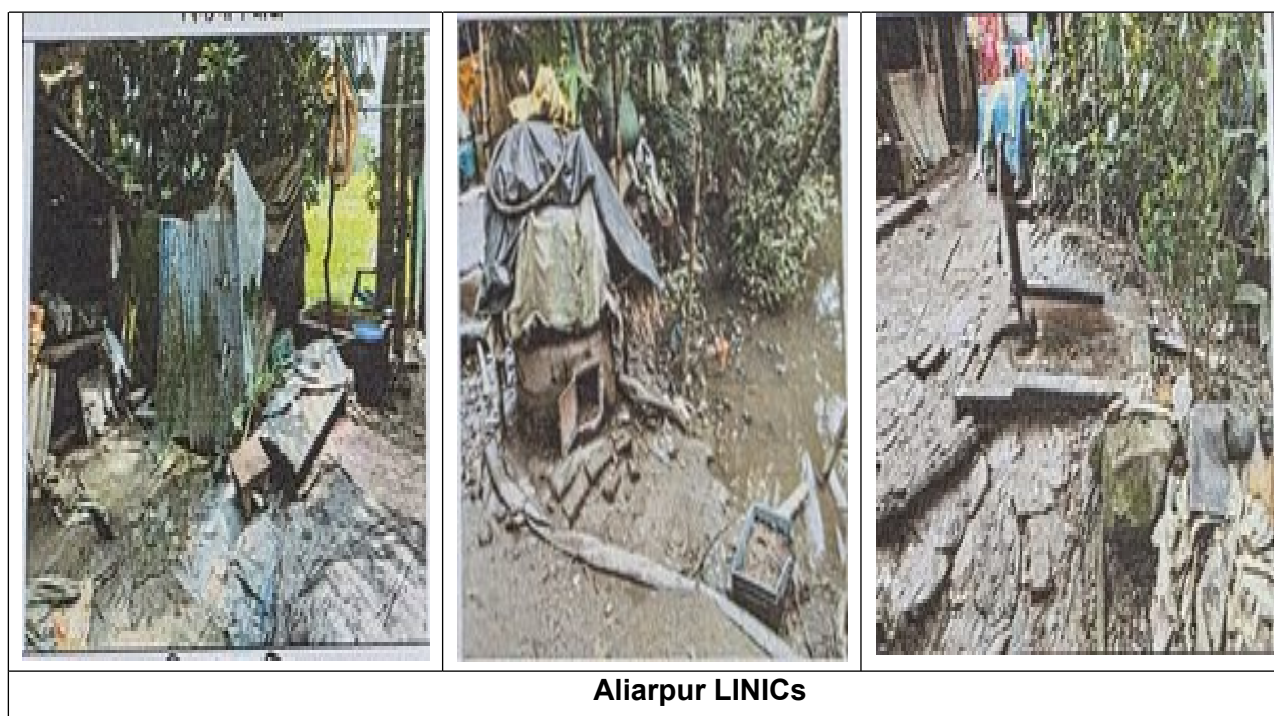
Figure IV.1: Existing Situation at **Aliarpur LIN****(v) Solar Street Lights**

13. There is no existing sufficient sanitary toilet facility in the LIN area. LIN dwellers are facing a scarcity of hygienic sanitation; refer to **Figure II.1** for the existing condition of toilet facilities. Hence, they have demanded the construction of 20 nos. of sanitary toilets to improve the sanitation condition of their area. Refer to **Appendix 1** for the typical design of the proposed improved toilet.

14. There is no existing paved road/walkway in the LIN area. Refer to **Figure II.1** for the existing condition of access roads. LIN dwellers want 381 m of footpaths for their improved communication system within the LIN area. The proposed footpaths have been designed with cement concrete (CC) pavement over a prepared sub-base with crushed stone chips and/or Single Layer Brick Flat Soling (BFS). The LIN area is connected to Pourashava roads. A typical design of the footpath is given in **Appendix 1**.

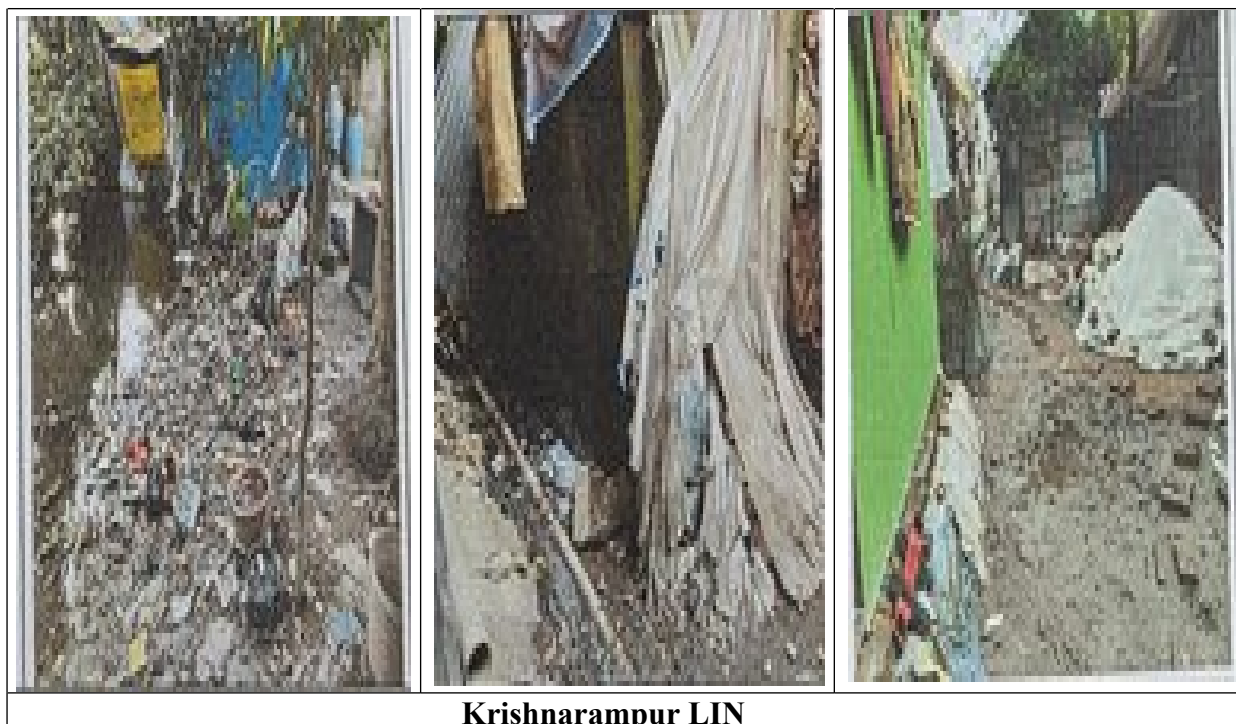
**Figure IV.2: Existing Situation at Krishnarampur LIN**

38. There exists earthen access road in the LIN area and no pacca walkway also in the LIN area. LIN dwellers wanted footpath for their communication within the LIN area. 137 m are being proposed in this summary. LIN area is connected by Pourashava roads. The proposed Footpaths have been designed with cement concrete (CC) crushed stone chips and over Single Layer Brick Flat Soling (BFS). LIN area is connected by Pourashava roads. Images of existing access roads of the LIN are shown in Figure II.3. Typical design of footpath is given in Appendix-1.

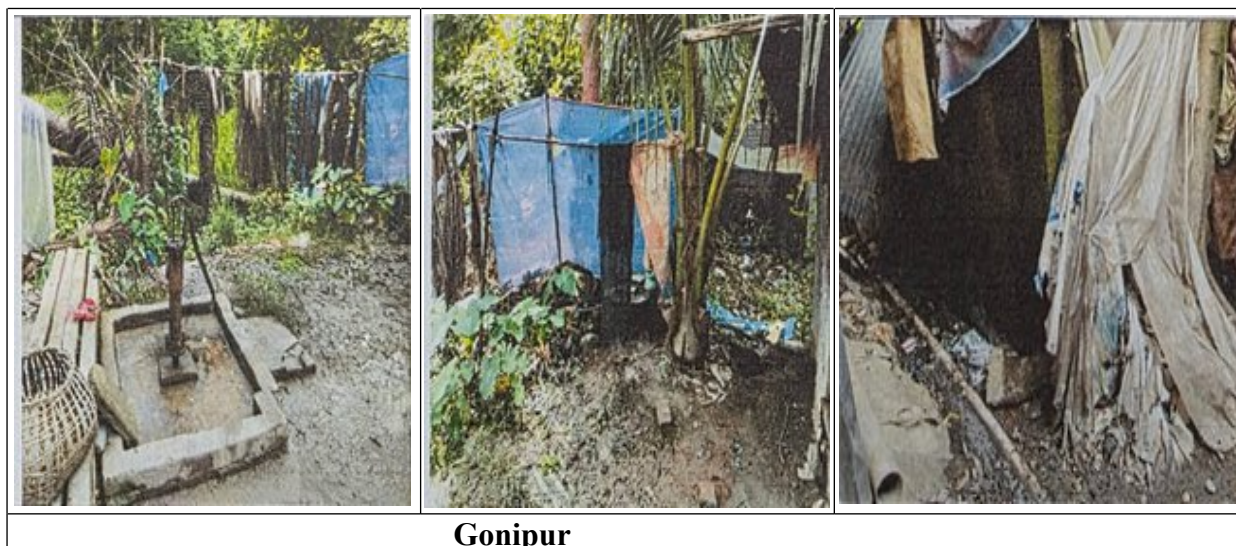
Figure IV.3: Existing Situation at Gonipur LIN

61. There is existing earth road are poor condition in the LIN area. LIN dwellers wanted footpath for their communication within the LIN area. The proposed footpaths 381m have been designed with cement concrete (CC) with crushed stone chips and over Single Layer Brick Flat Soling (BFS). LIN area is connected by Pourashava roads.

63. The existing drains are earthen and are inactive. So, the LIN dwellers experience water logging especially during rainy season. The out fall of proposed drain is Poura secondary drain to primary drain (Section-3 site map) and because as the coming water to the proposed drain is only from rainfall run-off or household waste water. All drains 390m have been designed to be built by RCC/brick. But well-defined slopes and outfalls have been ensured. The U-type drains have been designed considering the constraint in land availability. The design life has been considered as 20 years. Integration/connection of Road side drains with the town drainage system has been considered and considering the possibilities of increased precipitation owing to probable climate change, the sections have been designed keeping allowance to accommodate 10% additional flow.
