Improving Urban Governance and Infrastructure Program (IUGIP)

**Environmental Screening Report for
LIN Upgradation at Haziganj Pourashava**

Sub-Project No: IUGIP/HAZI/SI/01-05/2023

March 2025

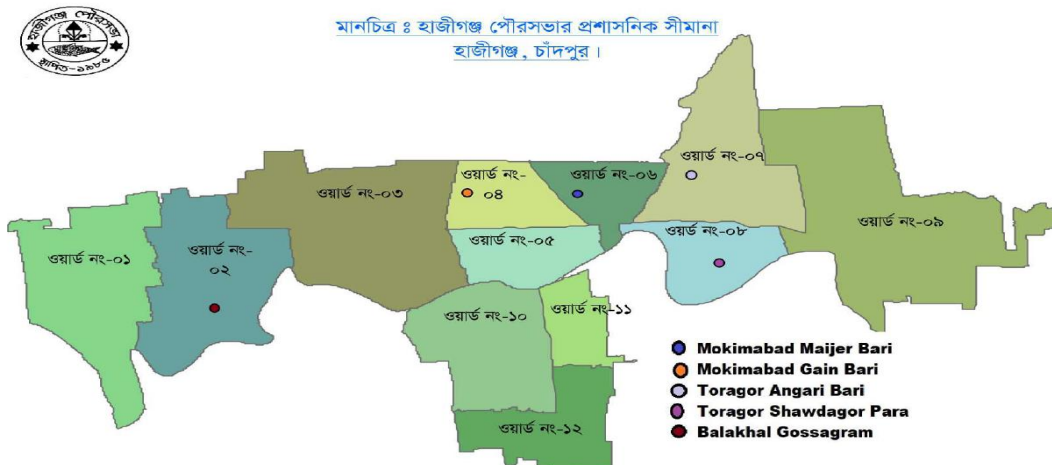
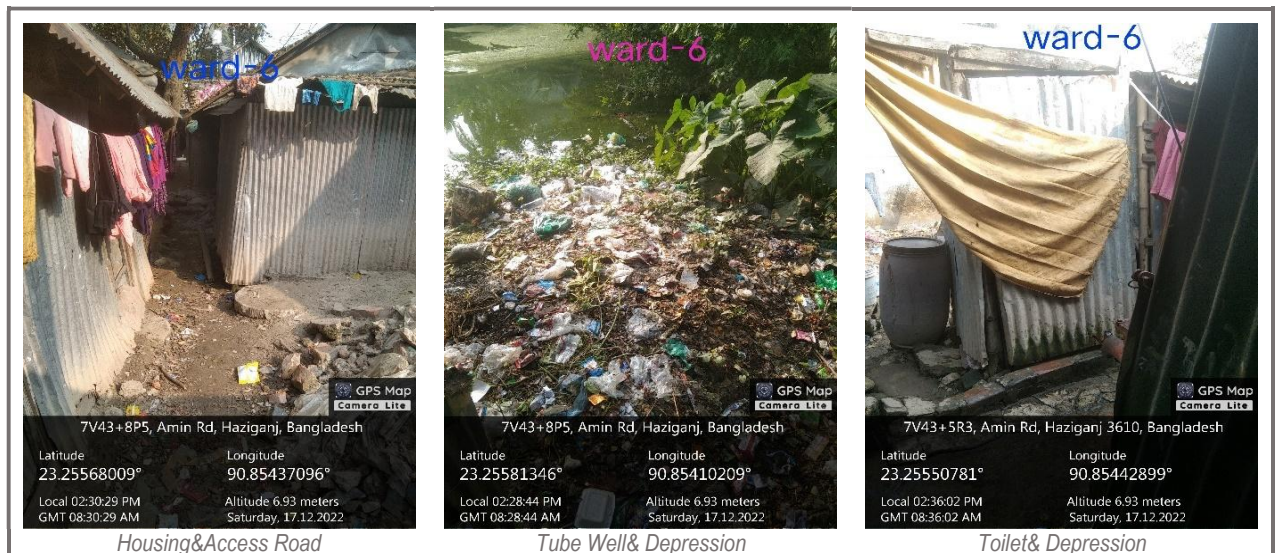
Figure IV.1: Existing Situation at Mokimabad Majjer Bari -LIN

13. There is no existing sufficient sanitary toilet facility in the LIN area. LIN dwellers are facing a scarcity of hygienic sanitation; refer to **Figure II.1** for the existing condition of toilet facilities. Hence, they have demanded the construction of 16 nos. of sanitary toilets to improve the sanitation condition of their area. Refer to **Appendix 1** for the typical design of the proposed improved toilet.

14. There is no existing paved road/walkway in the LIN area. Refer to **Figure II.1** for the existing condition of access roads. LIN dwellers want 50m of footpaths for their improved communication system within the LIN area. The proposed footpaths have been designed with cement concrete (CC) pavement over a prepared sub-base with crushed stone chips and/or Single Layer Brick Flat Soling (BFS). The LIN area is connected to Pourashava roads. A typical design of the footpath is given in **Appendix 1**.

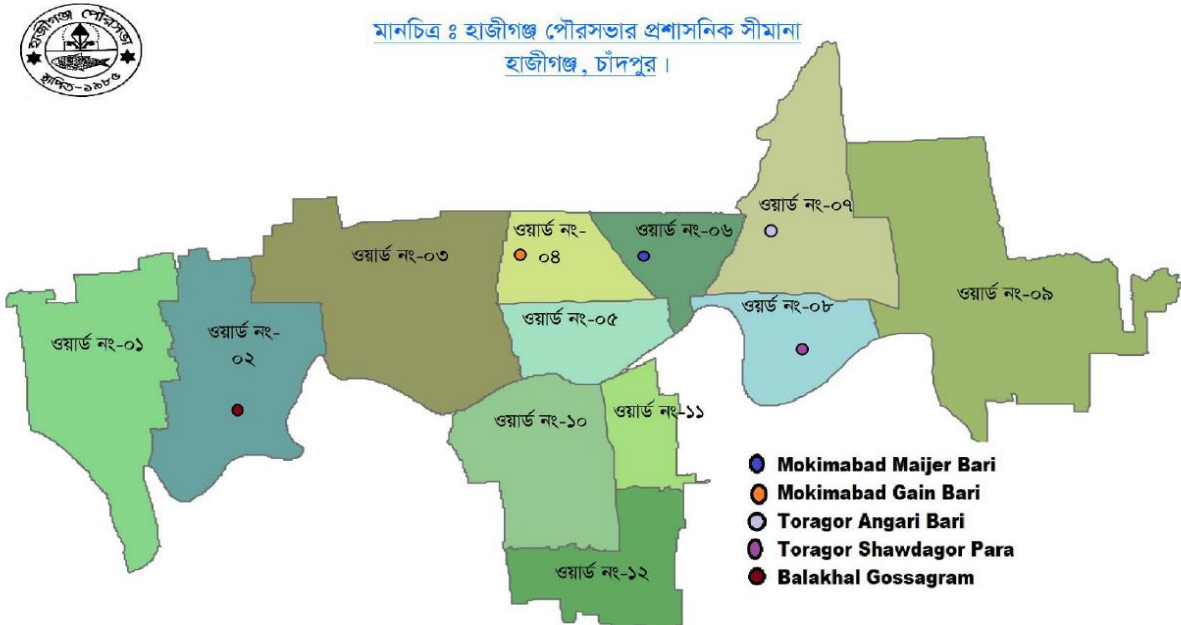
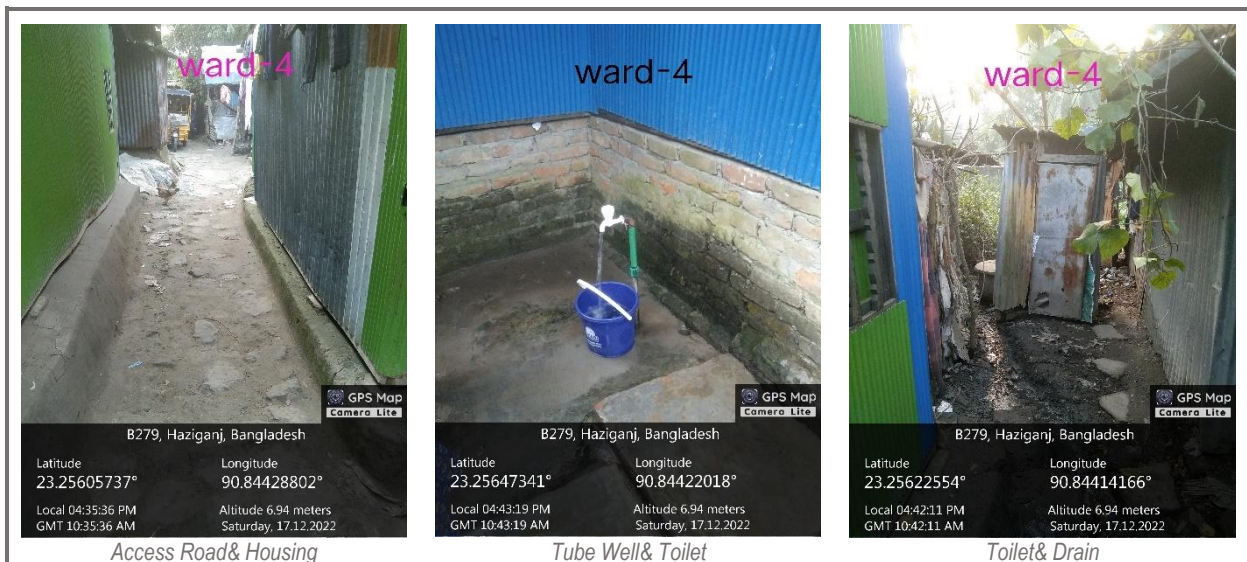
Figure IV.2: Existing Situation at Mokimabad Gain Bari LIN

32. Flood does not occur in this LIN. The existing drains are earthen and are not functioning. Water logging condition occurs due to heavy rainfall during rainy season. Rain water in the monsoon and the water coming out from bathing and washing round the year are stagnant there. As such water logging becomes a common feature there. Construction of drain is necessary in this LIN.

35. There exists earthen access road in the LIN area and no pacca walkway also in the LIN area. LIN dwellers wanted footpath for their communication within the LIN area. 200 m are being proposed in this summary. LIN area is connected by Pourashava roads. The proposed Footpaths have been designed with cement concrete (CC) crushed stone chips and over Single Layer Brick Flat Soling (BFS). LIN area is connected by Pourashava roads. Images of existing access roads of the LIN are shown in Figure II.3. Typical design of footpath is given in Appendix-1.

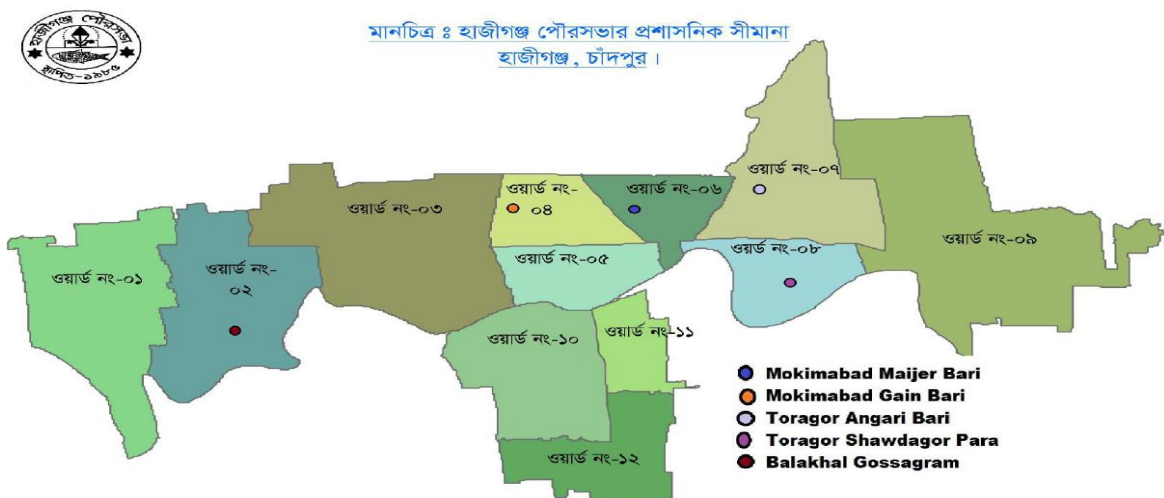
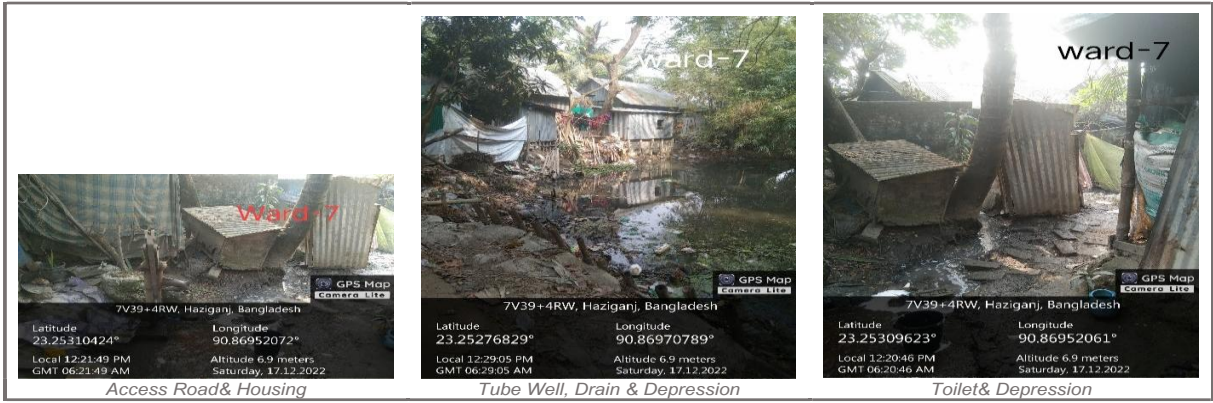
Figure IV.3: Existing Situation of Drain at Toragor Angari Bari LIN

vi. The existing drains are earthen and are inactive. So, the LIN dwellers experience water logging especially during rainy season. The out fall of proposed drain is Poura secondary drain to primary drain (Section-3 site map) and because as the coming water to the proposed drain is only from rainfall run-off or household waste water. All drains have been designed to be built by RCC/brick. But well-defined slopes and outfalls have been ensured. The U-type drains have been designed considering the constraint in land availability. The design life has been considered as 20 years. Integration/connection of Road side drains with the town drainage system has been considered and considering the possibilities of increased precipitation owing to probable climate change, the sections have been designed keeping allowance to accommodate 10% additional flow.

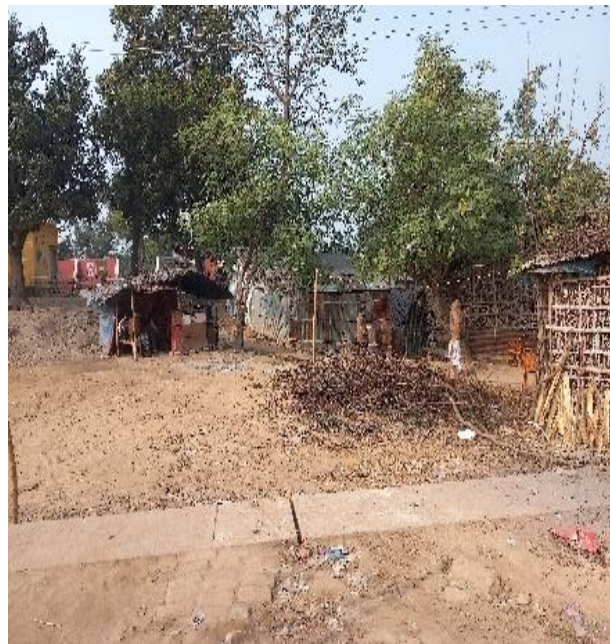
Figure IV.4: Existing Situation of Footpath Toragar Shawdagar Para Area LIN

There is no existing paved road/walkway in the LIN area. Refer to **Figure II.1** for the existing condition of access roads. LIN dwellers want 175m of footpaths for their improved communication system within the LIN area. The proposed footpaths have been designed with cement concrete (CC) pavement over a prepared sub-base with crushed stone chips and/or Single Layer Brick Flat Soling (BFS). The LIN area is connected to Pourashava roads. A typical design of the footpath is given in **Appendix 1**.

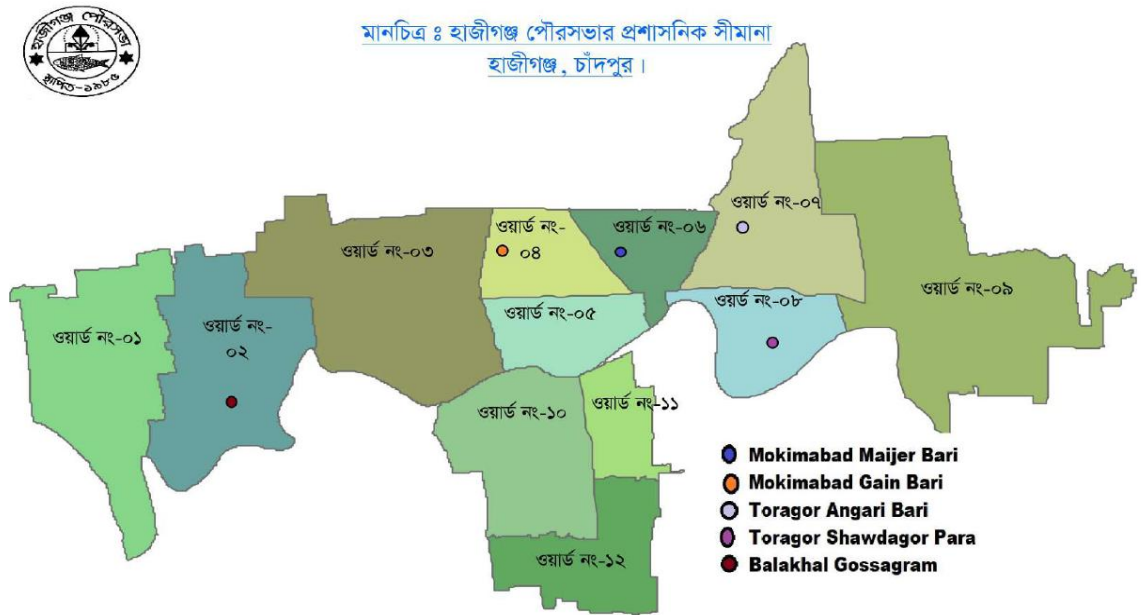
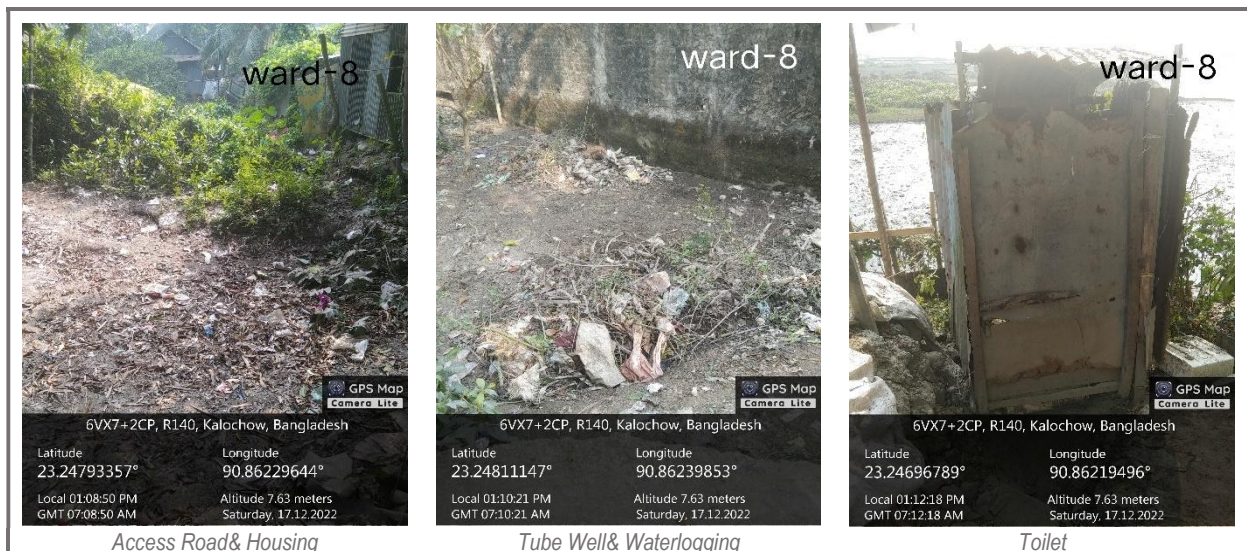
Figure IV.5: Existing Situation at Toragor Shawdagor Para LIN

The existing drains are earthen and are inactive. So, the LIN dwellers experience water logging especially during rainy season. The out fall of proposed drain is Paura secondary drain to primary drain (Section-3 site map) and because as the coming water to the proposed drain is only from rainfall run-off or household waste water. All drains have been designed to be built by RCC/brick. But well-defined slopes and outfalls have been

ensured. The U-type drains have been designed considering the constraint in land availability. The design life has been considered as 20 years. Integration/connection of Road side drains with the town drainage system has been considered and considering the possibilities of increased precipitation owing to probable climate change, the sections have been designed keeping allowance to accommodate 10% additional flow.

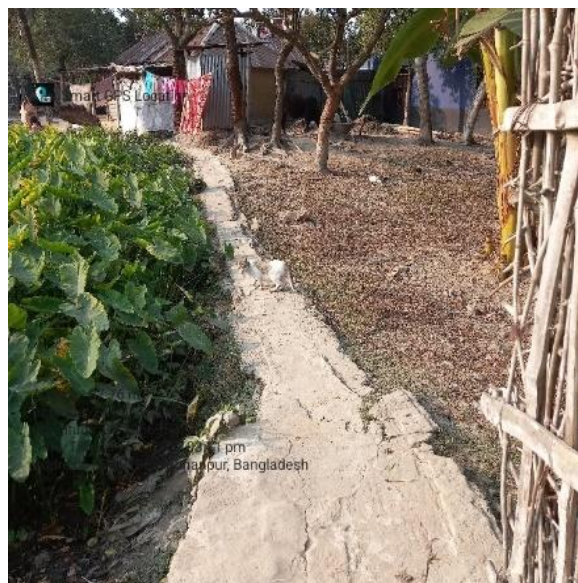
Figure IV.6: Existing Situation of Footpath at Balakhal Goccu Gram LIN

There is existing earth road are poor condition in the LIN area. LIN dwellers wanted footpath for their communication within the LIN area. The proposed footpaths have been designed with cement concrete (CC) with crushed stone chips and over Single Layer Brick Flat Soling (BFS). 107 m of footpaths are being proposed in this proposal.
