**Improving Urban Governance and Infrastructure Program (IUGIP)**

**Environmental Screening Report for  
LIN Upgradation at Khagrachari Pourashava**

**Sub-Project No: IUGIP/KHAG/SI/01-05/2023**

*April 2025*

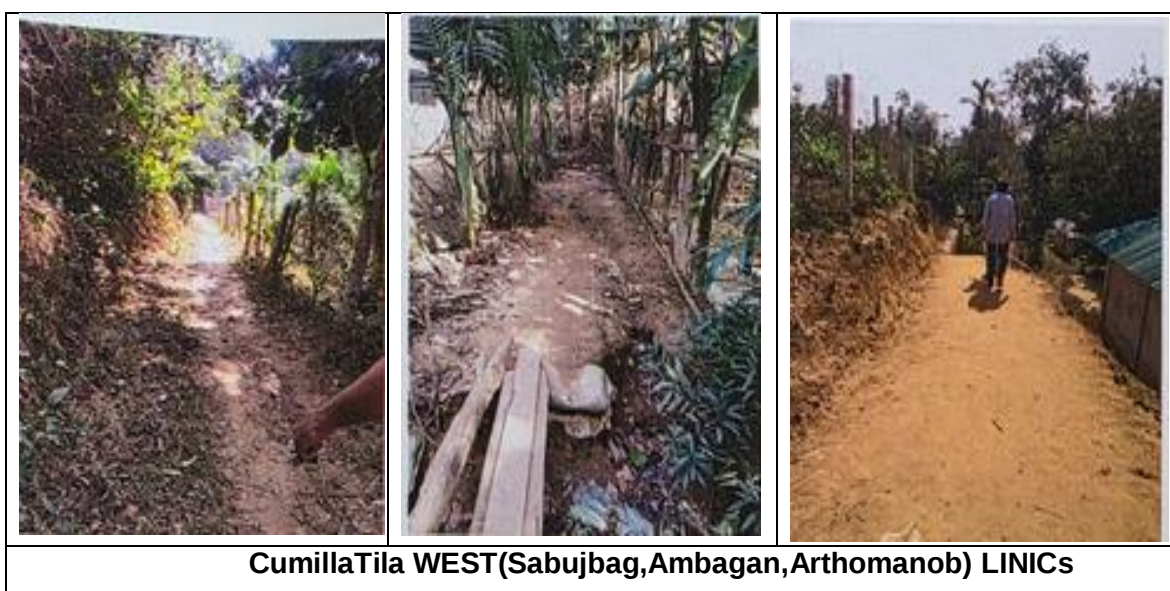
Figure IV.4: Existing Situation at Cumilla Tila WEST(Sabujbag,Ambagan,Arthomanob) LIN

91. The existing drains are earthen and are inactive. So, the LIN dwellers experience water logging especially during rainy season. The out fall of proposed drain is Paura secondary drain to primary drain (Section-3 site map) and because as the coming water to the 243m proposed drain is only from rainfall run-off or household waste water. But well-defined slopes and outfalls have been ensured. The U-type drains have been designed considering the constraint in land availability. The design life has been considered as 20 years. Integration/connection of Road side drains with the town drainage system have been considered and considering the possibilities of increased precipitation owing to probable climate change, the sections have been designed keeping allowance to accommodate 10% additional flow.
