**Improving Urban Governance and Infrastructure Program (IUGIP)**

**Environmental Screening Report for  
LIN Upgradation at Madhupur Pourashava**

**Sub-Project No: IUGIP/MADH/SI/01-04/2023**

*September 2025*

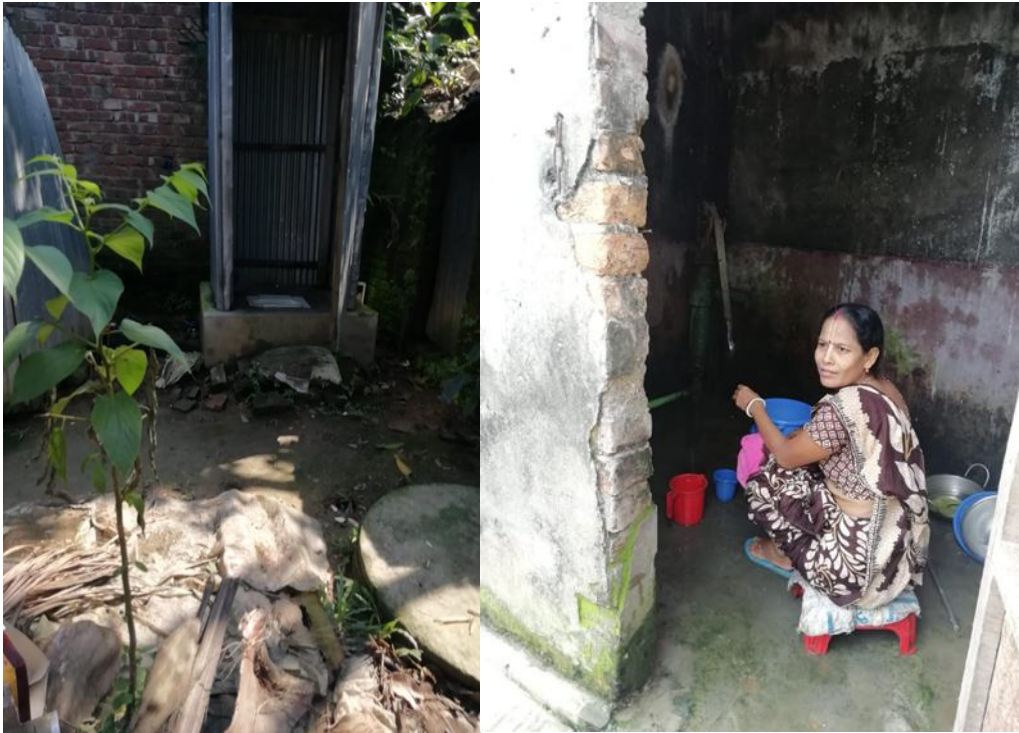
**Figure IV.1: Existing Situation at Saudhagor LIN**

13. There is no existing sufficient sanitary toilet facility in the LIN area. LIN dwellers are facing a scarcity of hygienic sanitation; refer to **Figure II.1** for the existing condition of toilet facilities. Hence, they have demanded the construction of 18 nos. of sanitary toilets to improve the sanitation condition of their area. Refer to **Appendix 1** for the typical design of the proposed improved toilet.

14. There is no existing paved road/walkway in the LIN area. Refer to **Figure II.1** for the existing condition of access roads. LIN dwellers want 193 m of footpaths for their improved communication system within the LIN area. The proposed footpaths have been designed with cement concrete (CC) pavement over a prepared sub-base with crushed stone chips and/or Single Layer Brick Flat Soling (BFS). The LIN area is connected to Pourashava roads. A typical design of the footpath is given in **Appendix 1**.

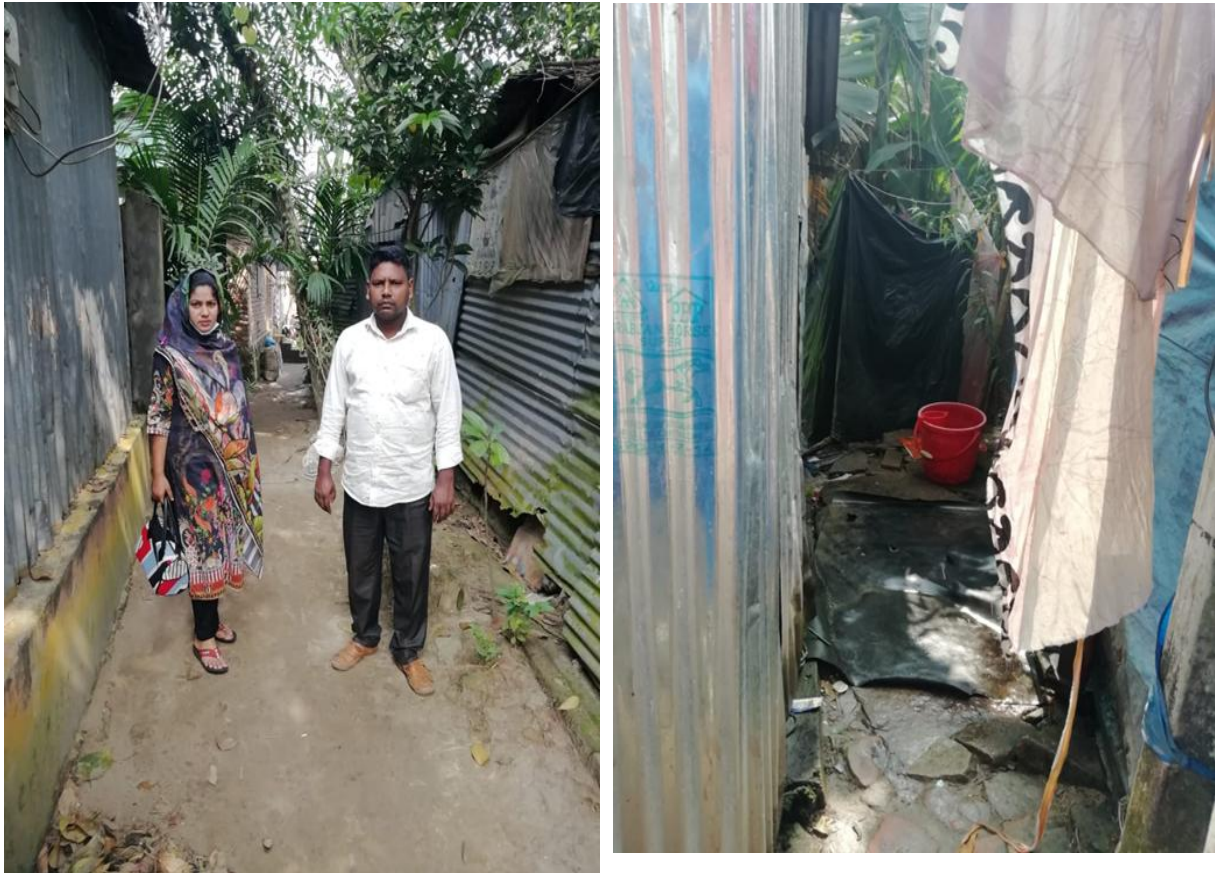
**Figure IV.2: Existing Situation at Rishipolly LIN**

35. There exists earthen access road in the LIN area and no pacca walkway also in the LIN area. LIN dwellers wanted footpath for their communication within the LIN area. 120 m are being proposed in this summary. LIN area is connected by Pourashava roads. The proposed Footpaths have been designed with cement concrete (CC) crushed stone chips and over Single Layer Brick Flat Soling (BFS). LIN area is connected by Pourashava roads. Images of

existing access roads of the LIN are shown in Figure II.3. Typical design of footpath is given in Appendix-1.

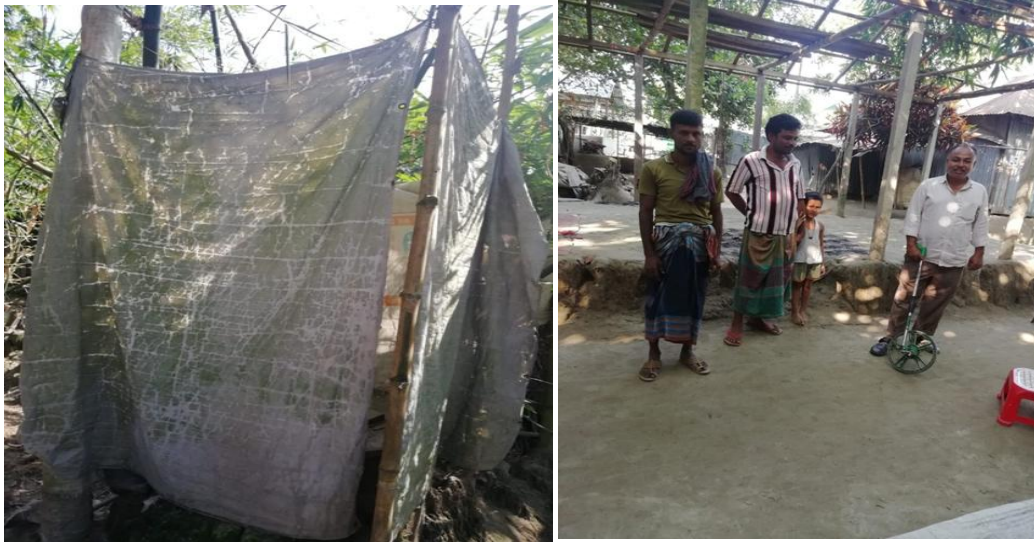
**Figure IV.4: Existing Situation at Sutarpara (Lot-04) LIN**

83. There are insufficient numbers of street light in this LIN area therefore 15nos provisions of light are proposed under this package.
