Improving Urban Governance and Infrastructure Program (IUGIP)

**Environmental Screening Report for
LIN Upgradation at Rohanpur Pourashava**

Sub-Project No: IUGIP/ROHA/SI/01-05/2023

March 2025

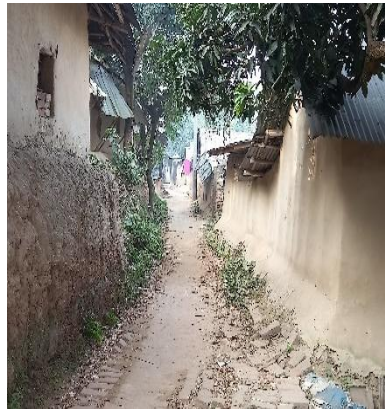
Figure IV.1: Existing Situation of Footpath at Rohanpur School para-LIN

There is no existing paved road/walkway in the LIN area. Refer to **Figure II.1** for the existing condition of access roads. LIN dwellers want 237m of footpaths for their improved communication system within the LIN area. The proposed footpaths have been designed with cement concrete (CC) pavement over a prepared sub-base with crushed stone chips and/or

Single Layer Brick Flat Soling (BFS). The LIN area is connected to Pourashava roads. A typical design of the footpath is given in **Appendix 1**

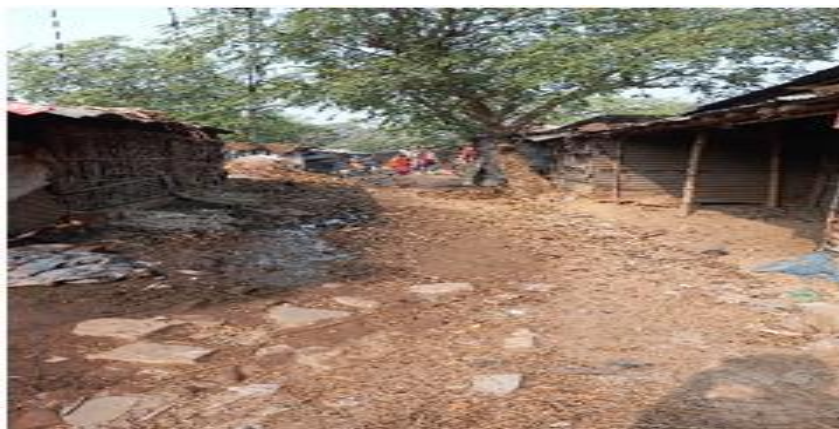
Figure IV.2: Existing Situation of Drain at Rohanpur School para-LIN

The existing drains are earthen and inactive. So, LIN dwellers experience water logging, especially during the rainy season. Hence, they have demanded construction of 60m of drains in their area. The proposed drains in the LINs have been considered tertiary drains, and their outfalls are all Paura secondary drains that discharge into primary drains. All drains have been designed to be built by RCC/brick. But well-defined slopes and outfalls have been ensured. The U-type drains have been designed considering the constraint in land availability. The design life has been considered as 20 years. Integration/connection of roadside drains with the town drainage system has been considered, and considering the possibilities of increased precipitation owing to probable climate change, the sections have been designed keeping allowance to accommodate 10% additional flow. A typical design of the drain is given in **Appendix 1**.

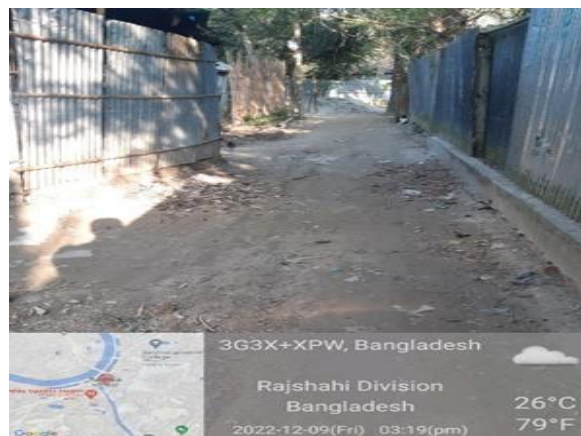
Figure IV.3: Existing Situation at Bohipara Daingpara LIN

There exists earthen access road in the LIN area and no pacca walkway also in the LIN area. LIN dwellers wanted footpath for their communication within the LIN area. 440 m are being proposed in this summary. LIN area is connected by Pourashava roads. The proposed Footpaths have been designed with cement concrete (CC) crushed stone chips and over Single Layer Brick Flat Soling (BFS). LIN area is connected by Pourashava roads. Images of existing access roads of the LIN are shown in Figure II.3. Typical design of footpath is given in Appendix-1.

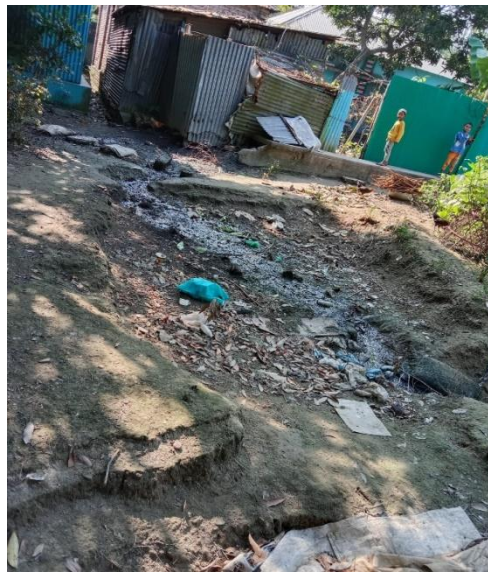
Figure IV.4: Existing Situation of Drain at Bohipara Daingpara LIN

The existing drains are earthen and are inactive. So, the LIN dwellers experience water logging especially during rainy season. The out fall of proposed drain is Pourashava existing drain (Section-3 site map) and the coming water to the proposed drain is only from rainfall run-off or household waste water. All drains have been designed to be built by RCC. But well-defined slopes and outfalls have been ensured. The U-type drains have been designed considering the constraint in land availability. The design life has been considered as 20 years. Integration/connection of Road side drains with the town drainage system has been considered and considering the possibilities of increased precipitation owing to probable climate change, the sections have been designed keeping allowance to accommodate 10% additional flow. Typical Design of drains is given in Appendix-1;

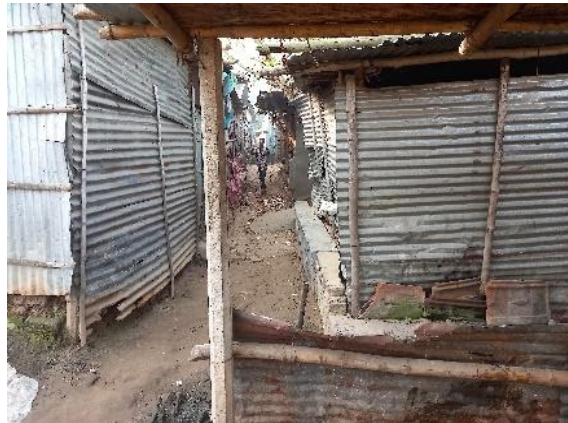
Figure IV.5: Existing Situation of Footpath at Belderpara(Rahmatpara) LIN

There is existing earth road are poor condition in the LIN area. LIN dwellers wanted footpath for their communication within the LIN area. The proposed footpaths have been designed with cement concrete (CC) with crushed stone chips and over Single Layer Brick Flat Soling (BFS). LIN area is connected by Pourashava roads.

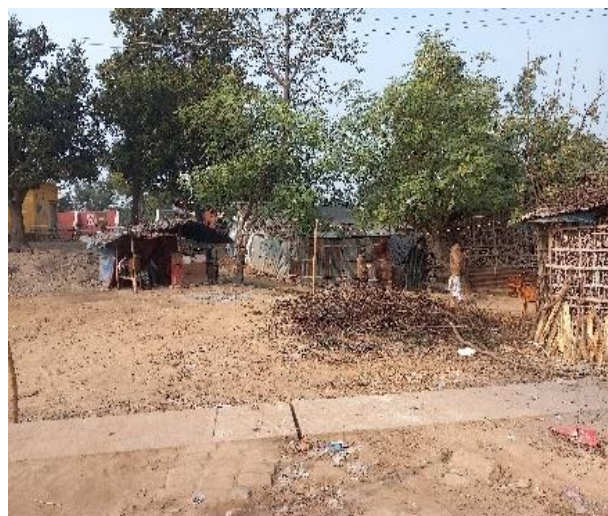
Figure IV.7: Existing Situation of Footpath at Hujrapur Area LIN

There is no existing paved road/walkway in the LIN area. Refer to Figure II.1 for the existing condition of access roads. LIN dwellers want 363m of footpaths for their improved communication system within the LIN area. The proposed footpaths have been designed with cement concrete (CC) pavement over a prepared sub-base with crushed stone chips and/or Single Layer Brick Flat Soling (BFS). The LIN area is connected to Pourashava roads. A typical design of the footpath is given in Appendix 1.

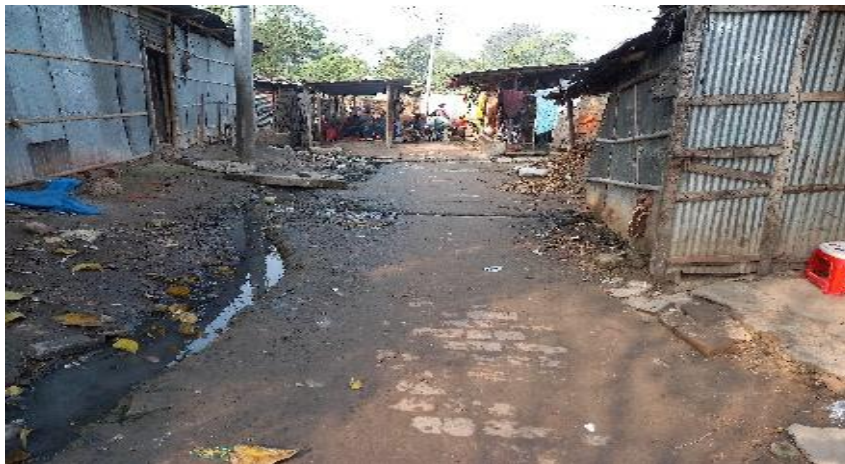
Figure IV.8: Existing Situation of Drain at Hujrapur LIN

The existing drains are earthen and are inactive. So, the LIN dwellers experience water logging especially during rainy season. The out fall of proposed drain is Poura secondary drain to primary drain (Section-3 site map) and because as the coming water to the proposed drain is only from rainfall run-off or household waste water. All drains have been designed to be built by RCC/brick. But well-defined slopes and outfalls have been ensured. The U-type drains have been designed considering the constraint in land availability. The design life has been considered as 20 years. Integration/connection of Road side drains with the town drainage system has been considered and considering the possibilities of increased precipitation owing to probable climate change, the sections have been designed keeping allowance to accommodate 10% additional flow.

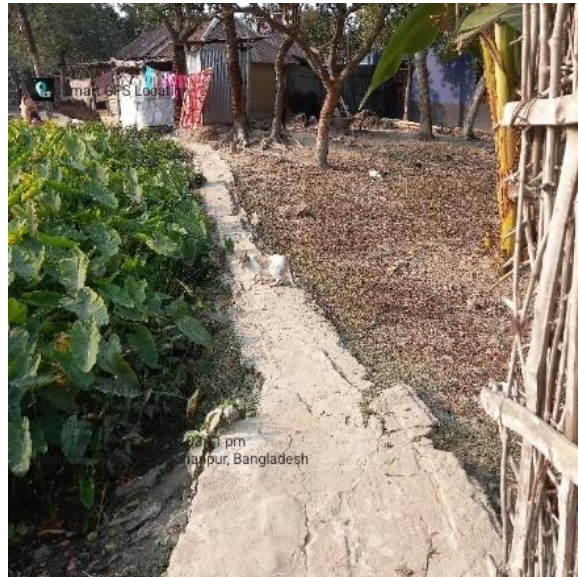
Figure IV.9: Existing Situation of Footpath at Gombujpara LIN

There is existing earth road are poor condition in the LIN area. LIN dwellers wanted footpath for their communication within the LIN area. The proposed footpaths have been designed with cement concrete (CC) with crushed stone chips and over Single Layer Brick Flat Soling (BFS). 403 m of footpaths are being proposed in this proposal.

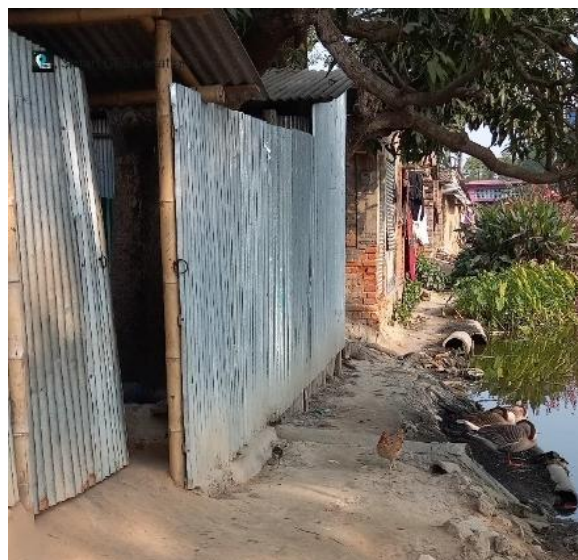
Figure IV.10: Existing Situation of Drain at Gombujpara LIN

The existing drains are earthen and are inactive. So, the LIN dwellers experience water logging especially during rainy season. The out fall of proposed drain is Poura secondary drain to primary drain (Section-3 site map) and because as the coming water to the proposed drain is only from rainfall run-off or household waste water. All drains have been designed to be built by RCC/brick. But well-defined slopes and outfalls have been ensured. The U-type drains have been designed considering the constraint in land availability. The design life has been considered as 20 years. Integration/connection of Road side drains with the town drainage system has been considered and considering the possibilities of increased precipitation owing to probable climate change, the sections have been designed keeping allowance to accommodate 10% additional flow.
