Improving Urban Governance and Infrastructure Program (IUGIP)

**Environmental Screening Report for
LIN Upgradation at SARIKANDI Pourashava**

Sub-Project No: IUGIP/SARI/SI/01-05/2023

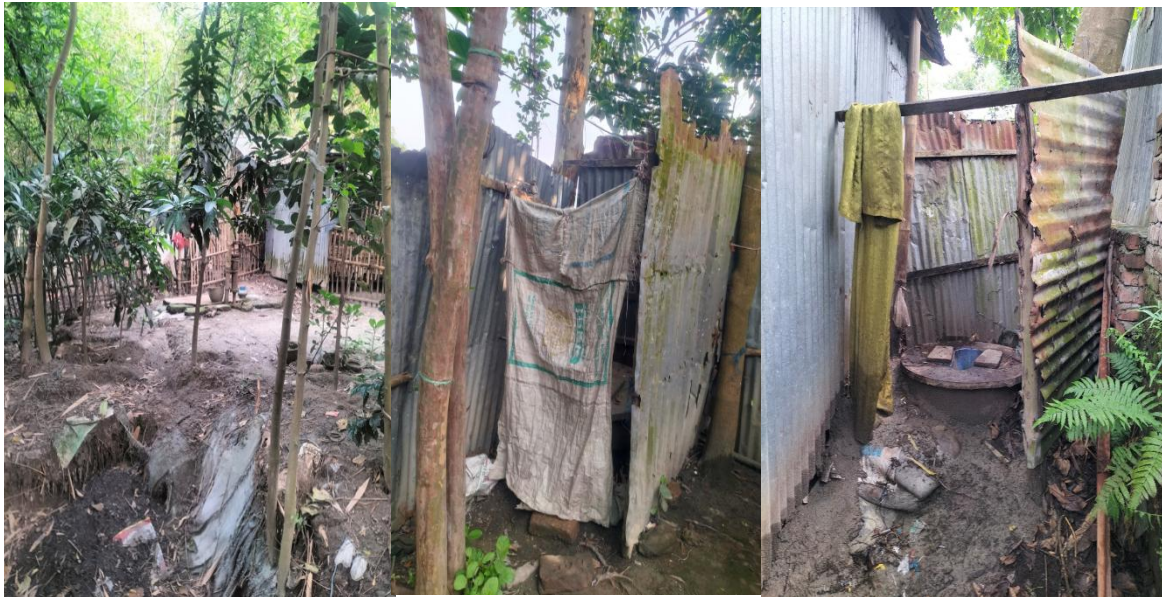
Figure IV.1: Existing Situation at Sahapara -LIN

13. There is no existing sufficient sanitary toilet facility in the LIN area. LIN dwellers are facing a scarcity of hygienic sanitation; refer to **Figure II.1** for the existing condition of toilet facilities. Hence, they have demanded the construction of 14 nos. of sanitary toilets to improve the sanitation condition of their area. Refer to **Appendix 1** for the typical design of the proposed improved toilet.

14. There is no existing paved road/walkway in the LIN area. Refer to **Figure II.1** for the existing condition of access roads. LIN dwellers want 300m of footpaths for their improved communication system within the LIN area. The proposed footpaths have been designed with cement concrete (CC) pavement over a prepared sub-base with crushed stone chips and/or Single Layer Brick Flat Soling (BFS). The LIN area is connected to Pourashava roads. A typical design of the footpath is given in **Appendix 1**.

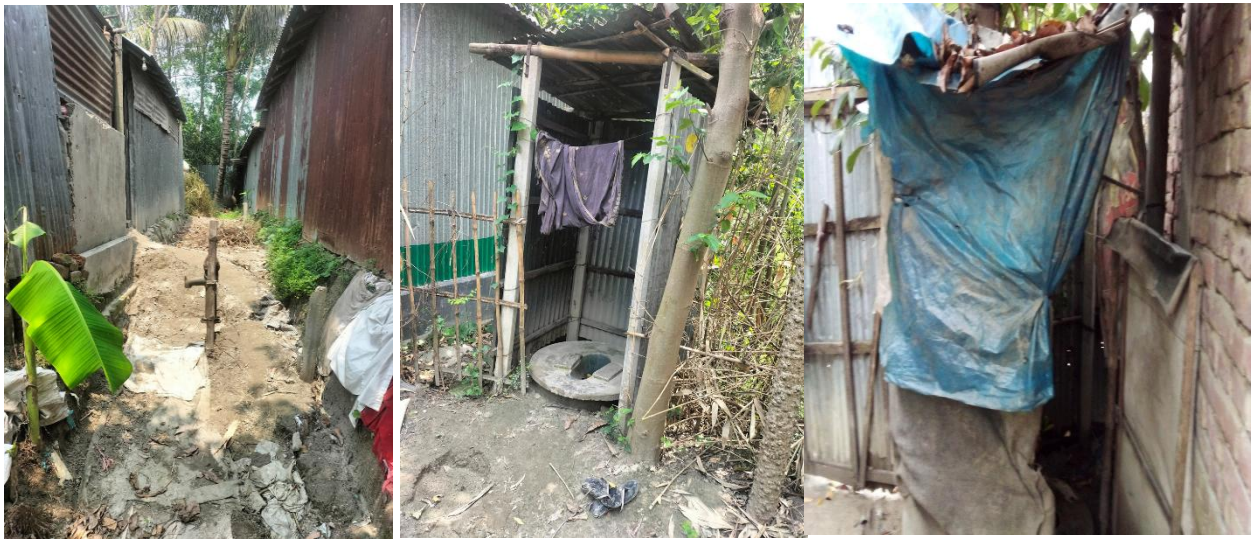
Figure IV.2: Existing Situation at Dokkhin Hindukandi LIN

34. Flood does not occur in this LIN. The existing drains are earthen and are not functioning. Water logging condition occurs due to heavy rainfall during rainy season. Rain water in the monsoon and the water coming out from bathing and washing round the year are stagnant there. As such water logging becomes a common feature there. Construction of drain is necessary in this LIN.

37. There exists earthen access road in the LIN area and no pacca walkway also in the LIN area. LIN dwellers wanted footpath for their communication within the LIN area. 512 m are being proposed in this summary. LIN area is connected by Pourashava roads. The proposed Footpaths have been designed with cement concrete (CC) crushed stone chips and over Single Layer Brick Flat Soling (BFS). LIN area is connected by Pourashava roads. Images of existing access roads of the LIN are shown in Figure II.3. Typical design of footpath is given in Appendix-1.

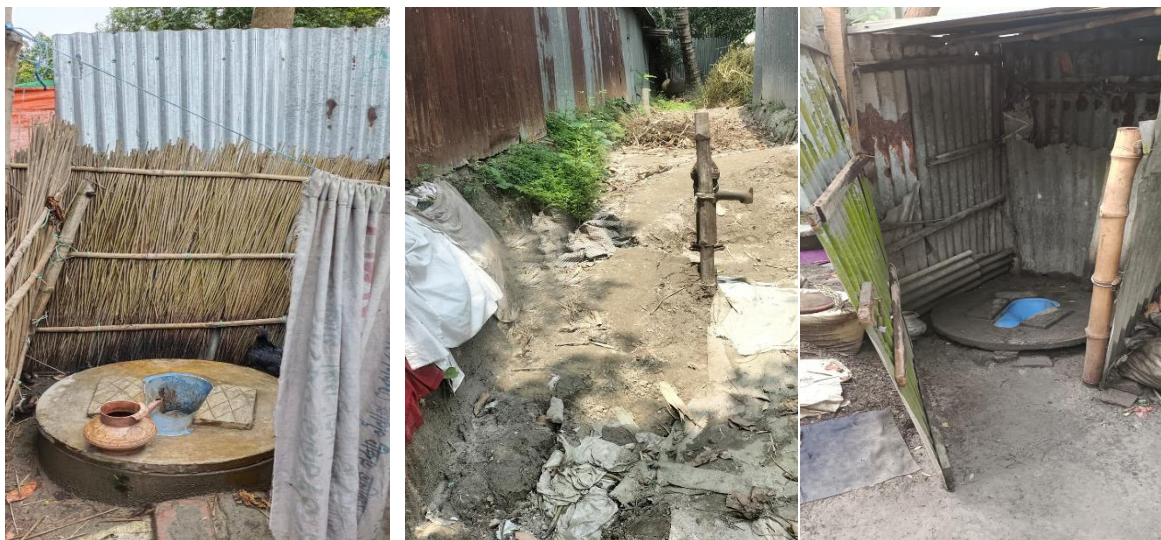
Figure IV.3: Existing Situation at Uttar Baroipara LIN

59. The existing drains are earthen and are inactive. So, the LIN dwellers experience water logging especially during rainy season. The out fall of proposed drain is Poura secondary drain to primary drain (Section-3 site map) and because as the coming water to the proposed drain is only from rainfall run-off or household waste water. All drains 150m have been designed to be built by RCC/brick. But well-defined slopes and outfalls have been ensured. The U-type drains have been designed considering the constraint in land availability. The design life has been considered as 20 years. Integration/connection of Road side drains with the town drainage system has been considered and considering the possibilities of increased precipitation owing to probable climate change, the sections have been designed keeping allowance to accommodate 10% additional flow.

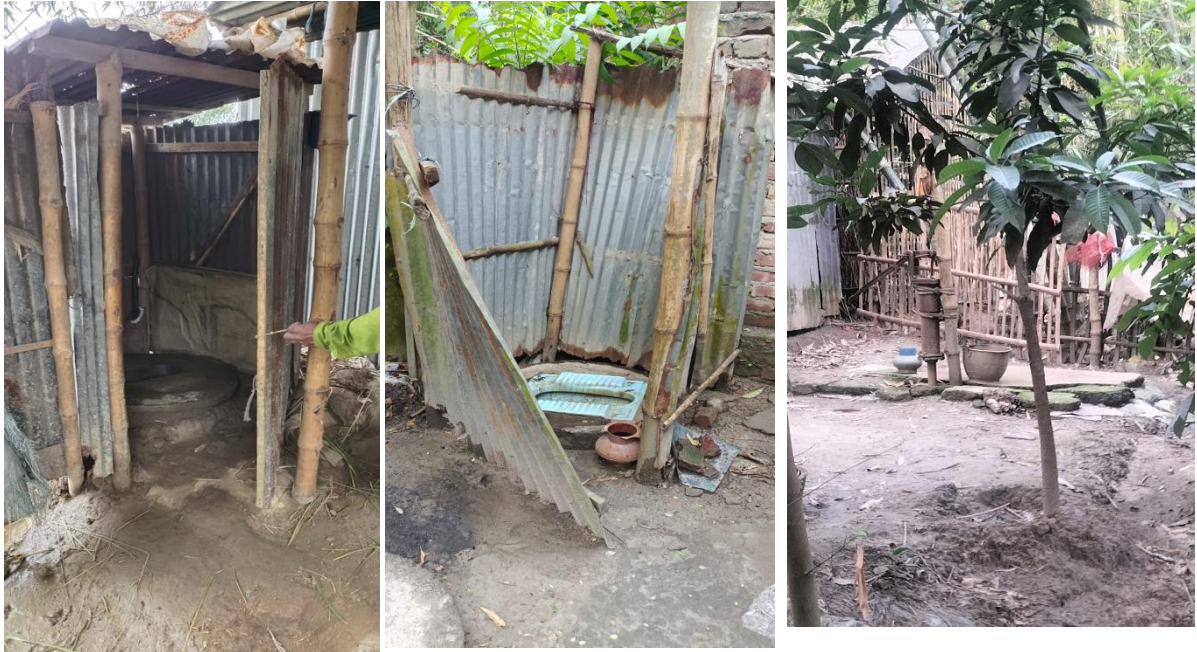
Figure IV.4: Existing Situation at Dokkhin Baroipara LIN

81. The existing drains are earthen and are inactive. So, the LIN dwellers experience water logging especially during rainy season. The out fall of proposed drain is Poura secondary drain to primary drain (Section-3 site map) and because as the coming water to the proposed drain is only from rainfall run-off or household waste water. All drains 70m have been designed to be built by RCC/brick. But well-defined slopes and outfalls have been ensured. The U-type drains have been designed considering the constraint in land availability. The design life has been considered as 20 years. Integration/connection of Road side drains with the town drainage system has been considered and considering the possibilities of increased precipitation owing to probable climate change, the sections have been designed keeping allowance to accommodate 10% additional flow.

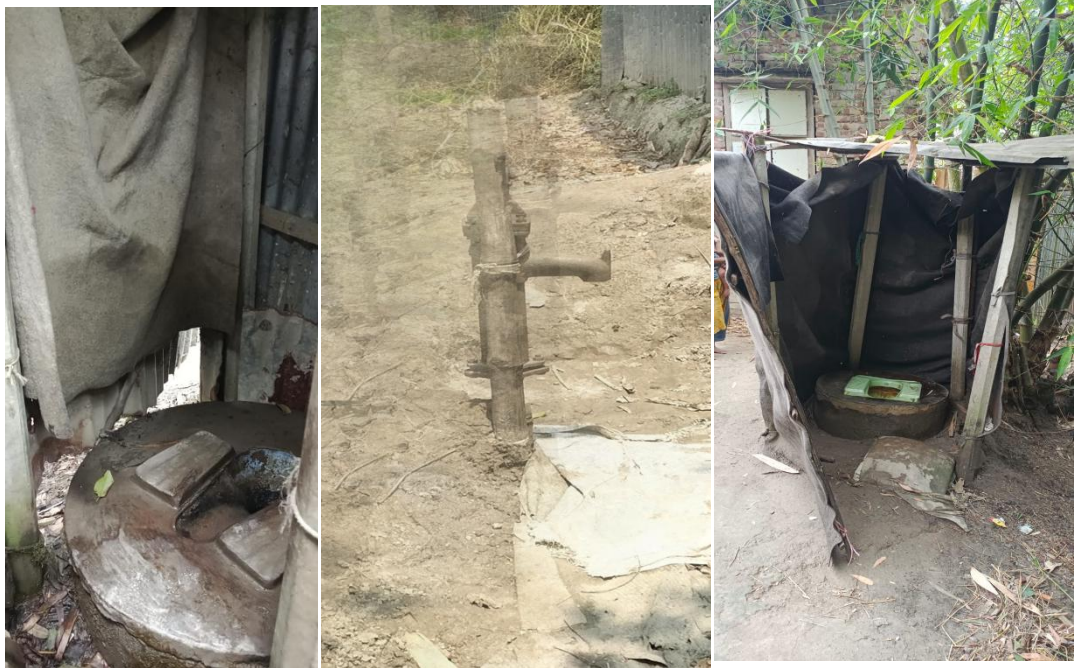
Figure IV.5: Existing Situation at Bagbero LIN

98. The existing drains are earthen and are inactive. So, the LIN dwellers experience water logging especially during rainy season. The out fall of proposed drain is Poura secondary drain to primary drain (Section-3 site map) and because as the coming water to the proposed drain is only from rainfall run-off or household waste water. All drains have been designed to be built by RCC/brick. But well-defined slopes and outfalls have been ensured. The U-type drains have been designed considering the constraint in land availability. The design life has been considered as 20 years. Integration/connection of Road side drains with the town drainage system has been considered and considering the possibilities of increased precipitation owing to probable climate change, the sections have been designed keeping allowance to accommodate 10% additional flow.
