**Improving Urban Governance and Infrastructure Program (IUGIP)**

**Environmental Screening Report for  
LIN Upgradation at GOALANDA Pourashava**

**Sub-Project No: IUGIP/GOAL/SI/01-05/2023**

**MAY 2025**

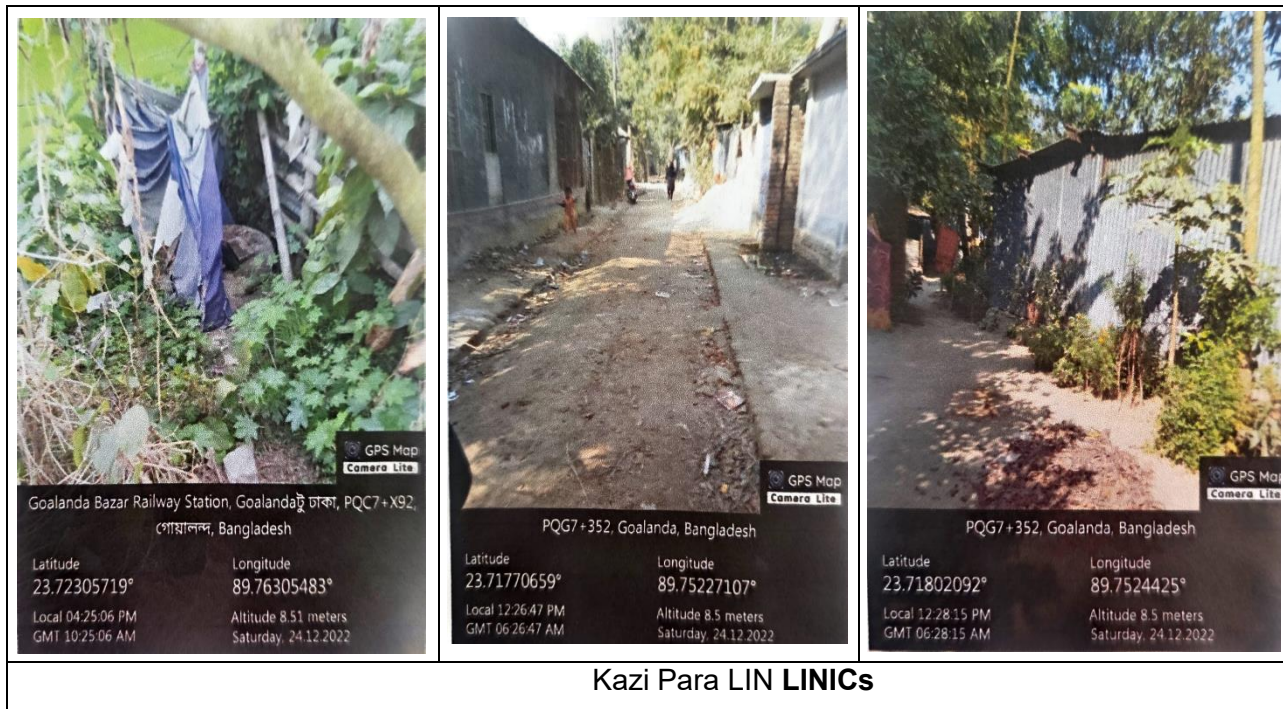
Figure IV.1: Existing Situation at **Kazi Para LIN**

13. There is no existing sufficient sanitary toilet facility in the LIN area. LIN dwellers are facing a scarcity of hygienic sanitation; refer to **Figure II.1** for the existing condition of toilet facilities. Hence, they have demanded the construction of 32 nos. of sanitary toilets to improve the sanitation condition of their area. Refer to **Appendix 1** for the typical design of the proposed improved toilet.

14. There is no existing paved road/walkway in the LIN area. Refer to **Figure II.1** for the existing condition of access roads. LIN dwellers want no footpaths for their improved communication system within the LIN area. The proposed footpaths have been designed with cement

concrete (CC) pavement over a prepared sub-base with crushed stone chips and/or Single Layer Brick Flat Soling (BFS). The LIN area is connected to Pourashava roads. A typical design of the footpath is given in **Appendix 1**.

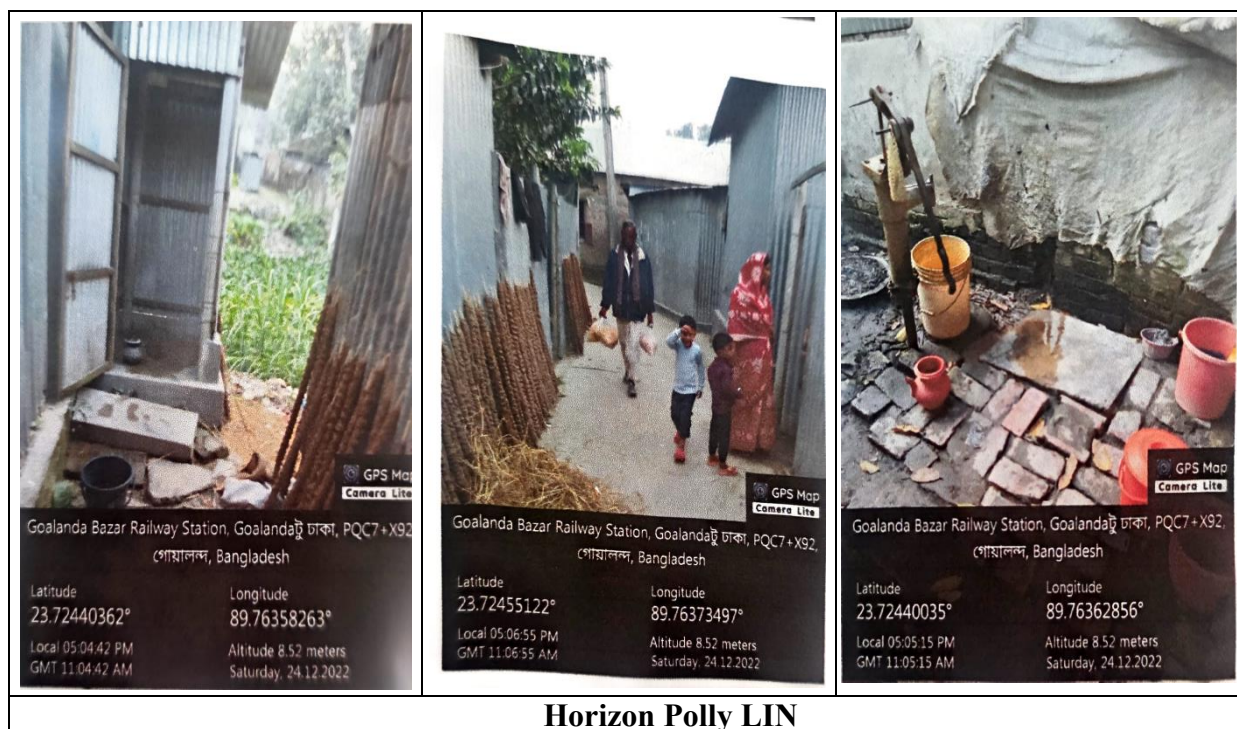
**Figure IV.2: Existing Situation at Horizon Polly LIN**

38. There exists earthen access road in the LIN area and no pacca walkway also in the LIN area. LIN dwellers wanted footpath for their communication within the LIN area. 130m are being proposed in this summary. LIN area is connected by Pourashava roads. The proposed Footpaths have been designed with cement concrete (CC) crushed stone chips and over Single Layer Brick Flat Soling (BFS). LIN area is connected by Pourashava roads. Images of existing access roads of the LIN are shown in Figure II.3. Typical design of footpath is given in Appendix-1.

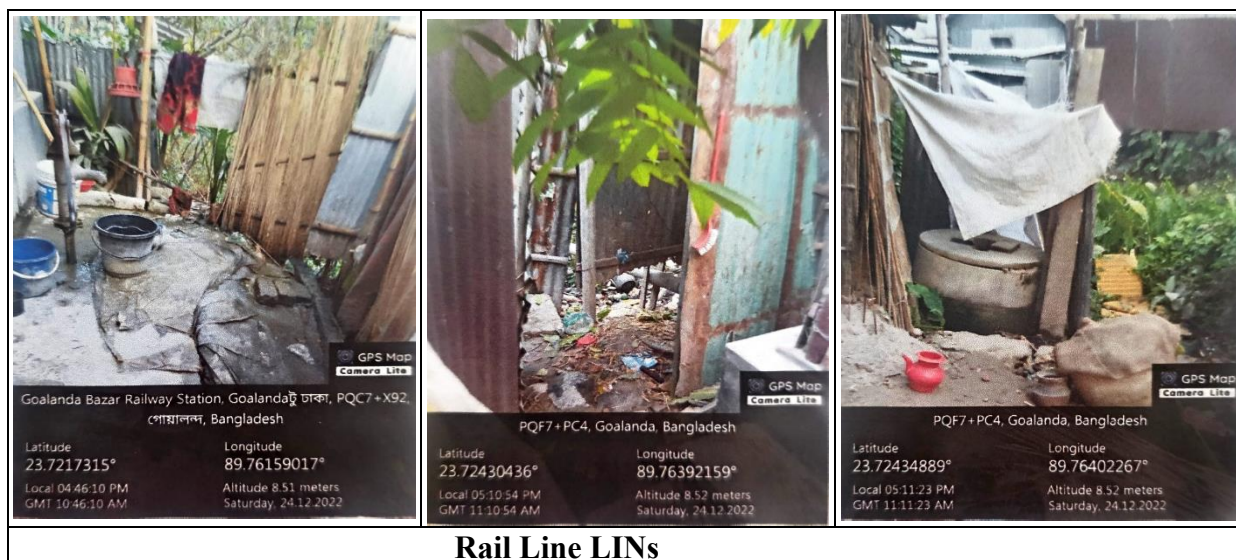
Figure IV.3: Existing Situation at Rail Line LIN

62. The existing drains are earthen and are inactive. So, the LIN dwellers experience water logging especially during rainy season. The out fall of proposed drain is Poura secondary drain to primary drain (Section-3 site map) and because as the coming water to the proposed drain is only from rainfall run-off or household waste water. All drains 140m have been designed to be built by RCC/brick. But well-defined slopes and outfalls have been ensured. The U-type drains have been designed considering the constraint in land availability. The design life has been considered as 20 years. Integration/connection of Road side drains with the town drainage system have been considered and considering the possibilities of increased precipitation owing to probable climate change, the sections have been designed keeping allowance to accommodate 10% additional flow.

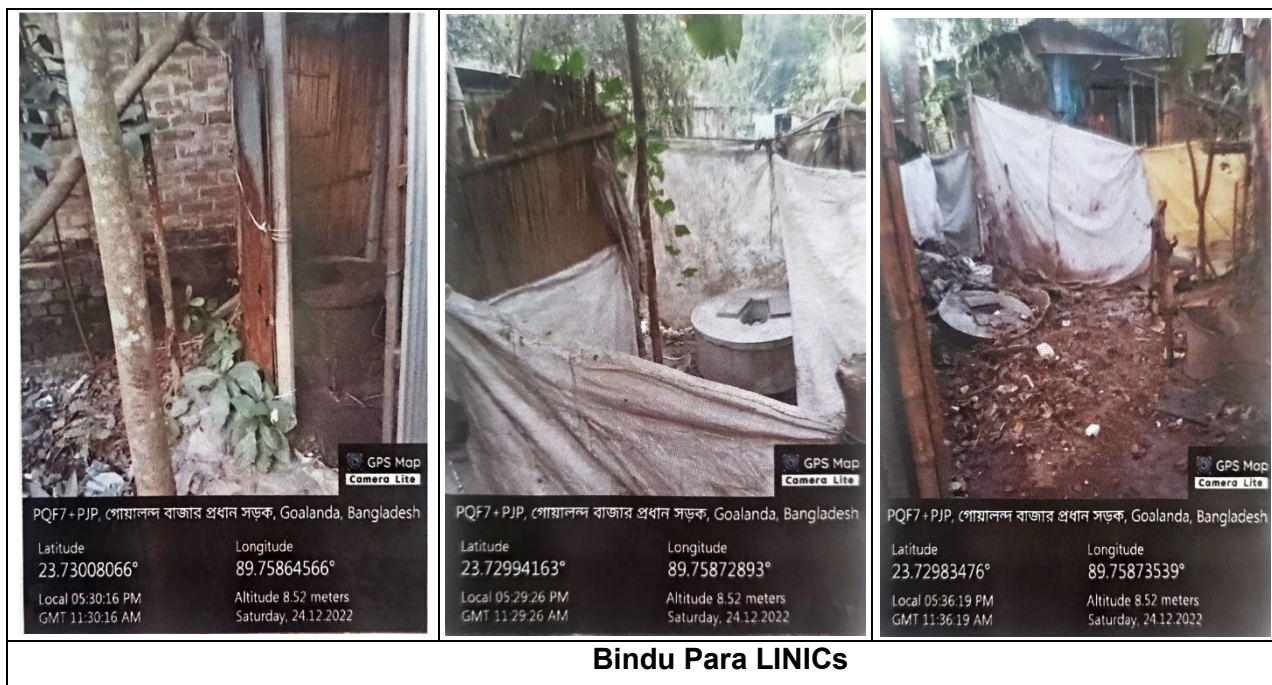
Figure IV.4: Existing Situation at Bindu Para LIN

88. The existing drains are earthen and are inactive. So, the LIN dwellers experience water logging especially during rainy season. The out fall of 130m proposed drain is Poura secondary drain to primary drain (Section-3 site map) and because as the coming water to the proposed drain is only from rainfall run-off or household waste water. But well-defined slopes and outfalls have been ensured. The U-type drains have been designed considering the constraint in land availability. The design life has been considered as 20 years. Integration/connection of Road side drains with the town drainage system have been considered and considering the possibilities of increased precipitation owing to probable climate change, the sections have been designed keeping allowance to accommodate 10% additional flow.

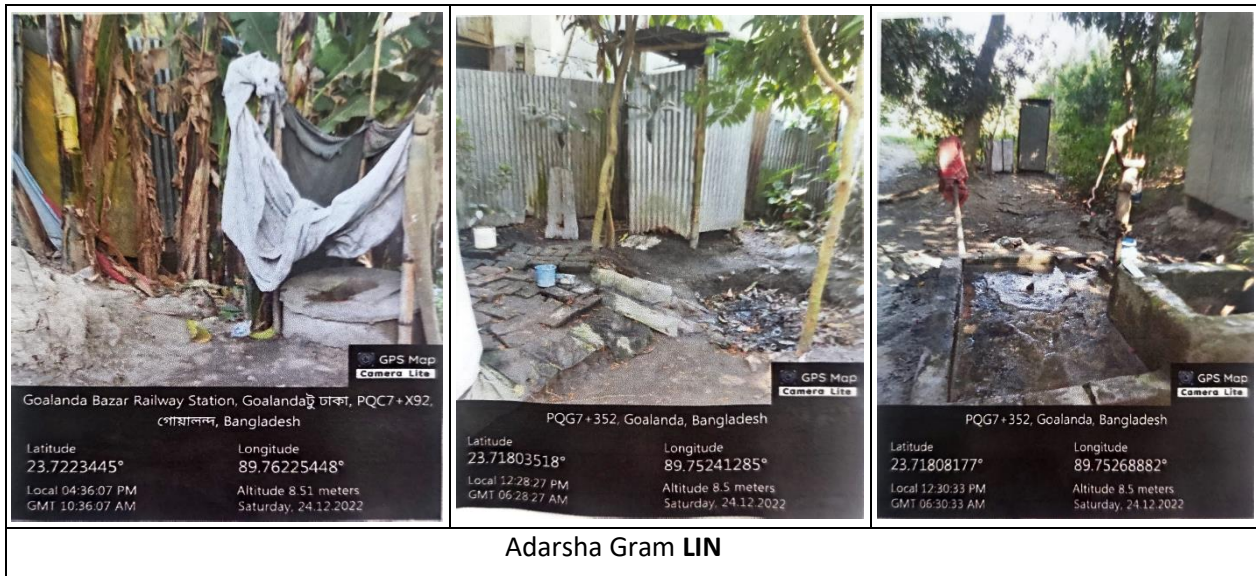
Figure IV.5: Existing Situation at Adarsha Gram LIN

109. The existing drains are earthen and are inactive. So, the LIN dwellers experience water logging especially during rainy season. The out fall of 100m proposed drain is Poura secondary drain to primary drain (Section-3 site map) and because as the coming water to the proposed drain is only from rainfall run-off or household waste water. All drains have been designed to be built by RCC/brick. But well-defined slopes and outfalls have been ensured. The U-type drains have been designed considering the constraint in land availability. The design life has been considered as 20 years. Integration/connection of Road side drains with the town drainage system has been considered and considering the possibilities of increased precipitation owing to probable climate change, the sections have been designed keeping allowance to accommodate 10% additional flow.
